# School District 5 Southeast Kootenay Long Range Facilities Plan

**MOUNT BAKER SECONDARY  
SCHOOL FACILITY REVIEW**

Prepared for School District 5,  
Southeast Kootenay

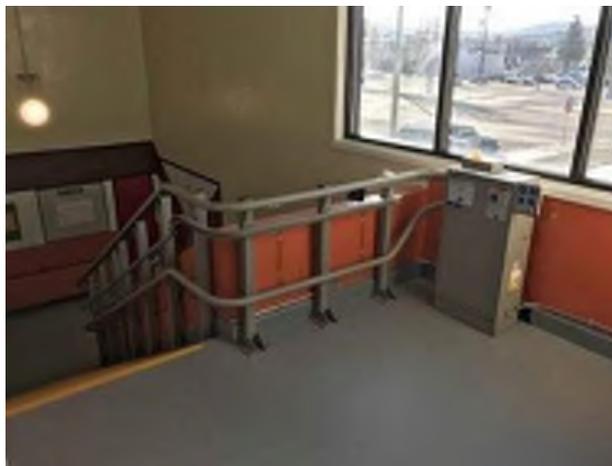
The school has several handicapped accessibility issues. Currently, there is a handrail lift on the front west stair, and a small lift was installed recently in the corridor of the north central wing on the second floor. While a handrail lift does provide vertical movement for people in wheelchairs, it does not address all the other items related to accessibility. These items include movement of equipment and the movement of stretchers and other emergency equipment. The handrail lift should be replaced with an elevator. There are also some areas of the school within the offices that are not fully accessible. The school should be 100% accessible to all students, staff, and visitors. This would be an expensive renovation to obtain, but it could be achieved.

*Handrail lift should be replaced with an elevator*

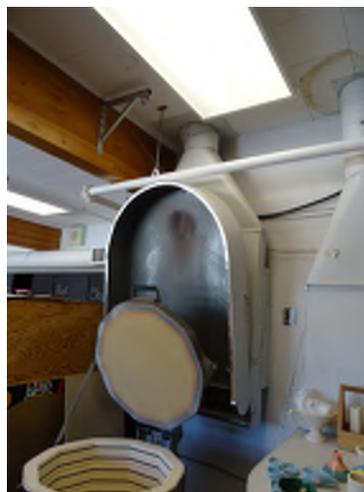
Overall, the north wing of the central original school is in fair condition, as a result of ongoing maintenance from the SD 5 team. This wing presents challenges for teaching in old style classrooms that have been converted and modernized several years ago. The art room on the second floor at the end of this wing has some code related issues with respect to the ventilation of the kiln in this space which must be addressed.

*Ventilation and safety concern with kiln in this Art Room*

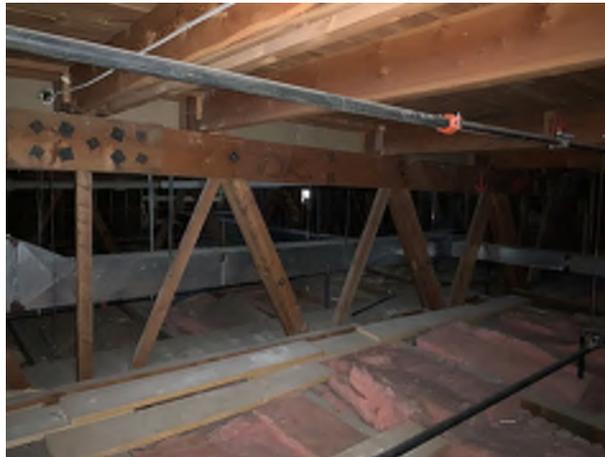
Photo #1 – Typical Heavy Timber Roof Trusses

The existing roof systems of the building are of varied construction types as noted in the previous reports and drawing sets. Structural repairs to some of the existing timber roof trusses have previously been completed as noted within the previous reports and were observed while on site. The existing roof systems appear to be in generally good condition with no significant signs of obvious visible structural distress observed.

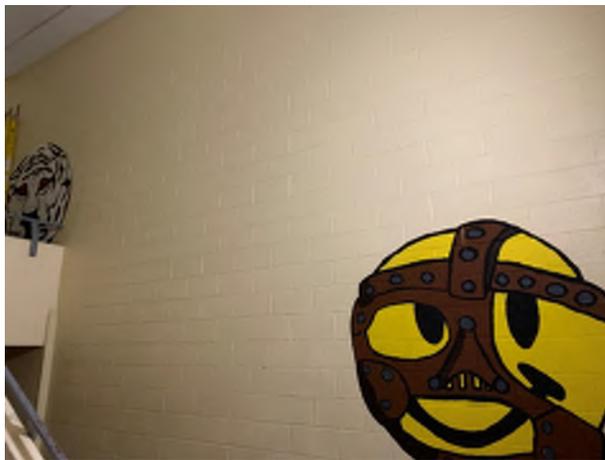
Photo #3 – Stairwell Masonry Wall

Bearing walls within the structure typically consist of wood framed bearing walls with some masonry walls at locations as noted on the previous reference drawing sets noted. The bearing walls and support columns appeared to be generally plumb with no significant lateral deflection observed.

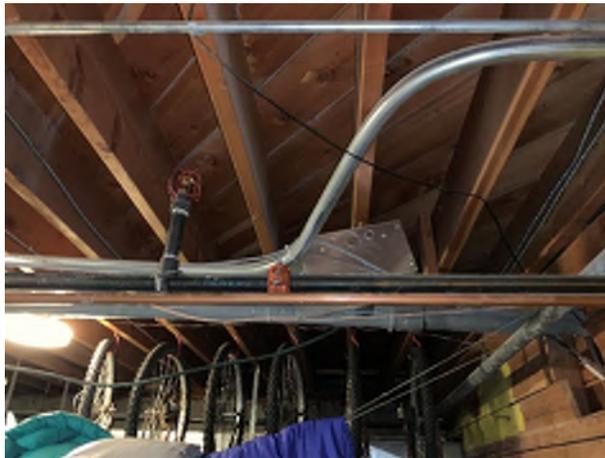
Photo #4 – Typical Floor System

The existing floor systems of the building are of varied construction types as noted in the previous reference reports and drawing sets. Some minor floor undulations were observed within the main floor classrooms of the original building as well as within the cafeteria area, however these undulations are relatively minor and do not appear to constitute a significant structural concern. The existing floor systems appear to be in generally good condition considering the age of the structure with no significant signs of obvious visible structural distress observed.

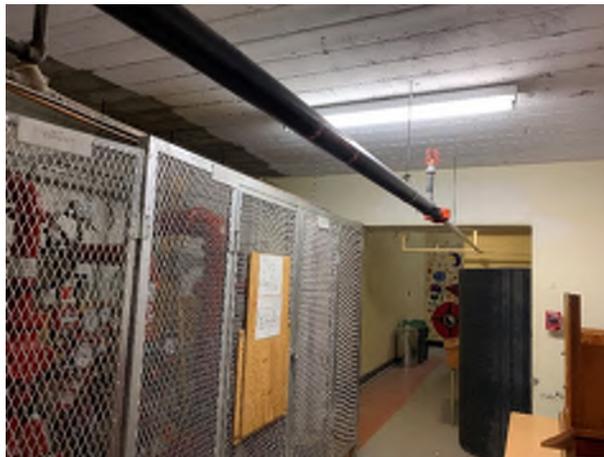
Photo #5 – Typical Suspended Slab System

The suspended concrete floor slab system which exists over the partial basement area of the building consists of a 5" thick reinforced concrete slab supported by intermediate assumed reinforced cast in place concrete beams which are supported by concrete foundation walls.

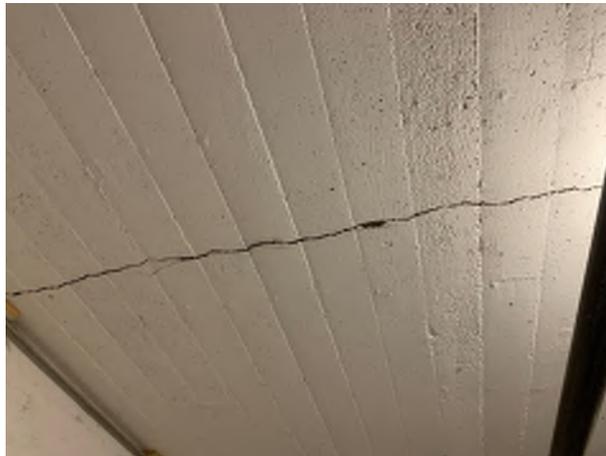
Photo #7 – Observed Suspended Slab Crack

One crack was observed within the floor slab over the corridor within the original building. This crack was noted within the 2009 Nelson Engineering report as well as in the 2019 Stantec report. Comparison of photos did not reveal any additional damage or displacement at the crack location indicating that the crack is likely not propagating. In other locations reviewed, the floor slab system generally appeared to be in reasonable condition considering the age of the building, with no obvious visible signs of structural distress observed.

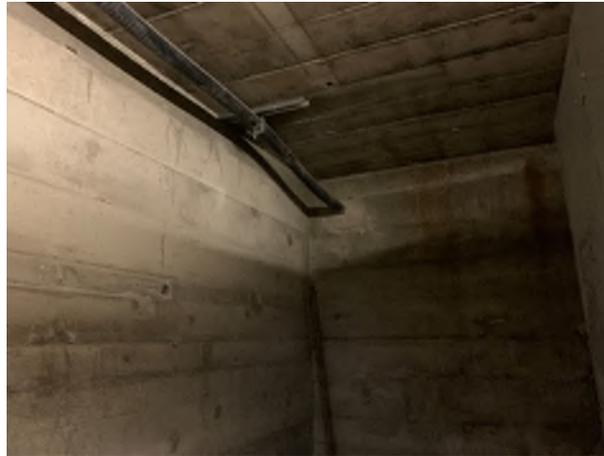
Photo #8 – Typical Foundation Walls

The foundations for the building appear to be of reinforced concrete construction, however due to the limited and non-intrusive nature of our review the vast majority of the foundations could not be visually reviewed. Within the basement area, the concrete foundation walls were exposed for our review. These walls appeared to be in reasonable condition with no obvious, visible signs of structural distress observed.

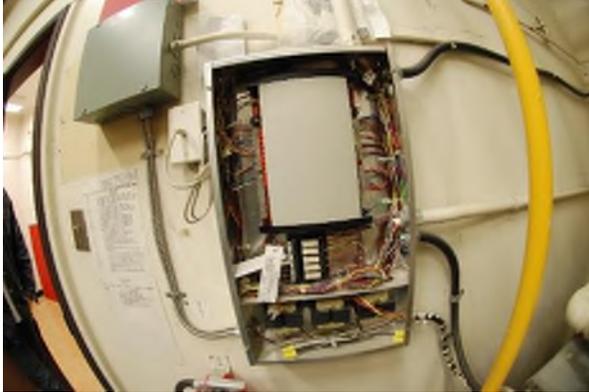
<p>Observations:</p> <ol style="list-style-type: none"> <li>1. The control system is a Delta Version 3.4 DDC system and is in “good” condition.</li> <li>2. The building has not been provided with CO2 measuring devices and cannot modulate outside air control to meet the requirements of the zones.</li> <li>3. Terminal system units for ancillary or unoccupied areas, such as entry ways and storage rooms, have not been provided with control that will prevent operation while the remainder of the building is in night setback.</li> </ol> <p>Recommendations:</p> <ol style="list-style-type: none"> <li>1. These systems will need to be upgraded to provide CO2 demand-based ventilation control.</li> <li>2. Reconfiguration will be required to suit the proposed design.</li> </ol>
---	--

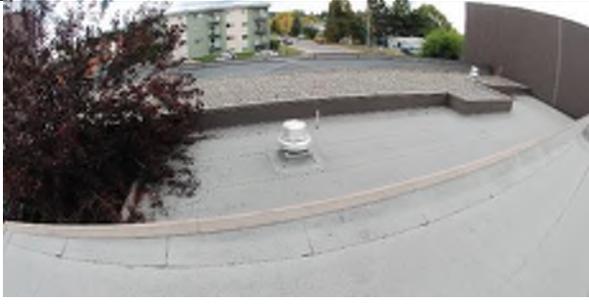
<p>Observations:</p> <ol style="list-style-type: none"> <li>1. Dedicated general exhaust systems have been provided for equipment that generates objectionable odours.</li> <li>2. The spun aluminum type roof mounted exhaust systems have suffered excessive vandalism.</li> </ol> <p>Recommendations:</p> <ol style="list-style-type: none"> <li>1. The exhaust fans should be replaced as required.</li> </ol>
---	--

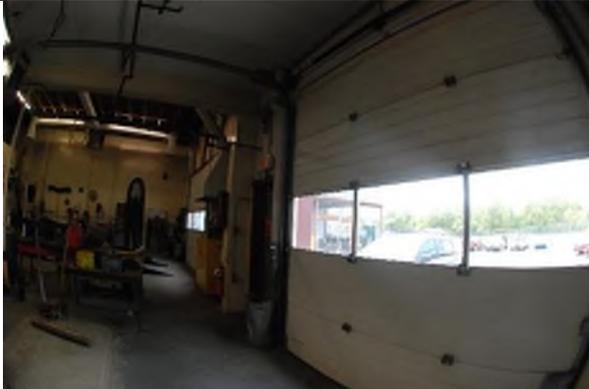
<p>Observations:</p> <ol style="list-style-type: none"> <li>1. Automotive carbon monoxide systems do not comply with current WorkSafeBC Guidelines and good engineering practice.</li> </ol> <p>Recommendations:</p> <ol style="list-style-type: none"> <li>1. Automotive exhaust systems should be upgraded.</li> </ol>
---	--

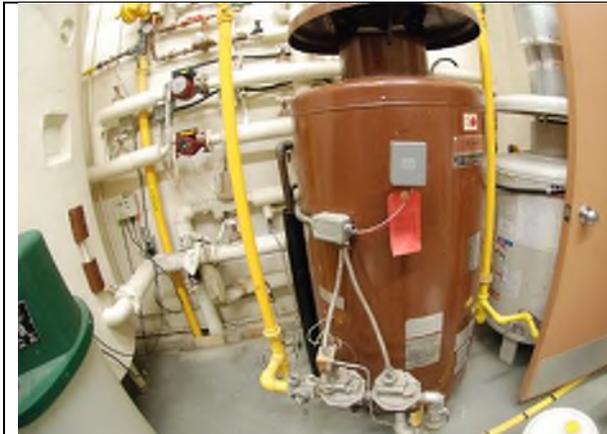
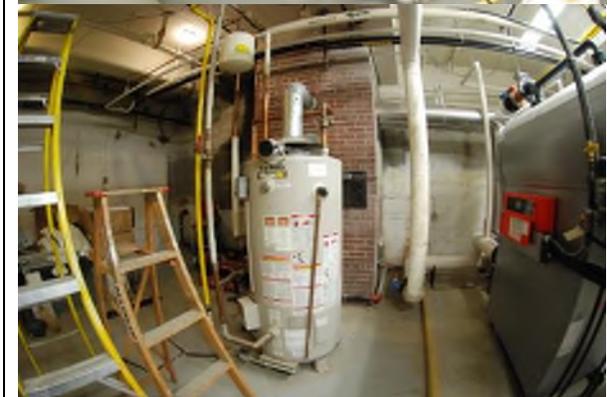
1. Domestic hot water heaters are gas fired natural draft units.
2. This style of heater is energy wasteful and has significant standby losses.
3. The Gym Changerooms and adjacent areas are served by two hot water heaters in the Gym Mechanical Room. The remainder of the school is served by a hot water heater in the main boiler room.
4. Two of the three hot water heaters have been recently replaced with new natural draft heaters.
5. The hot water heaters are in "fair" condition.

1. As the hot water heaters approach the end of their service lives, they should be replaced with condensing hot water heaters.

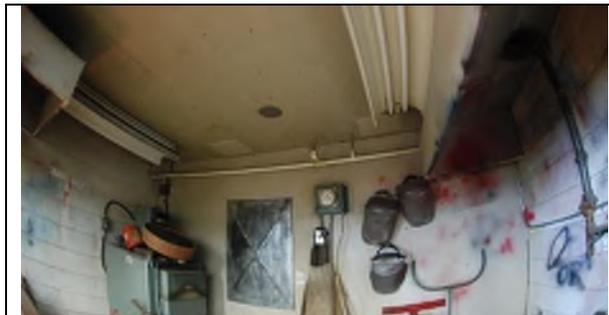
<p>Observations:</p> <ol style="list-style-type: none"> <li>1. Forge Area – if a sprinkler head operates while the forge or melting crucible are heating, the contact between the water and hot or molten metal can have dangerous consequences.</li> </ol>
	<p>Recommendations:</p> <ol style="list-style-type: none"> <li>1. Sprinkler heads should be removed from areas where the spray could make direct contact with forge or melting crucible.</li> </ol>

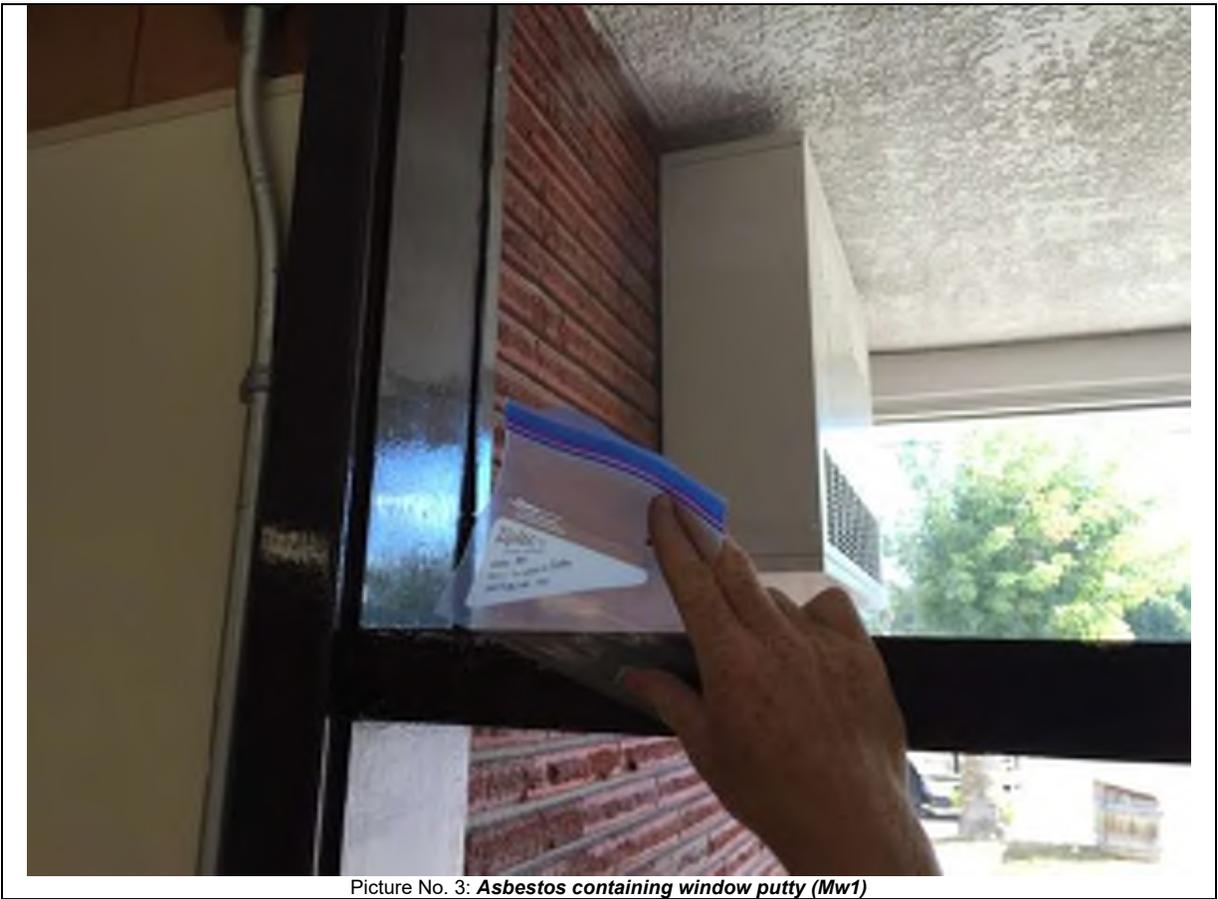
Picture No. 3: *Asbestos containing window putty (Mw1)*

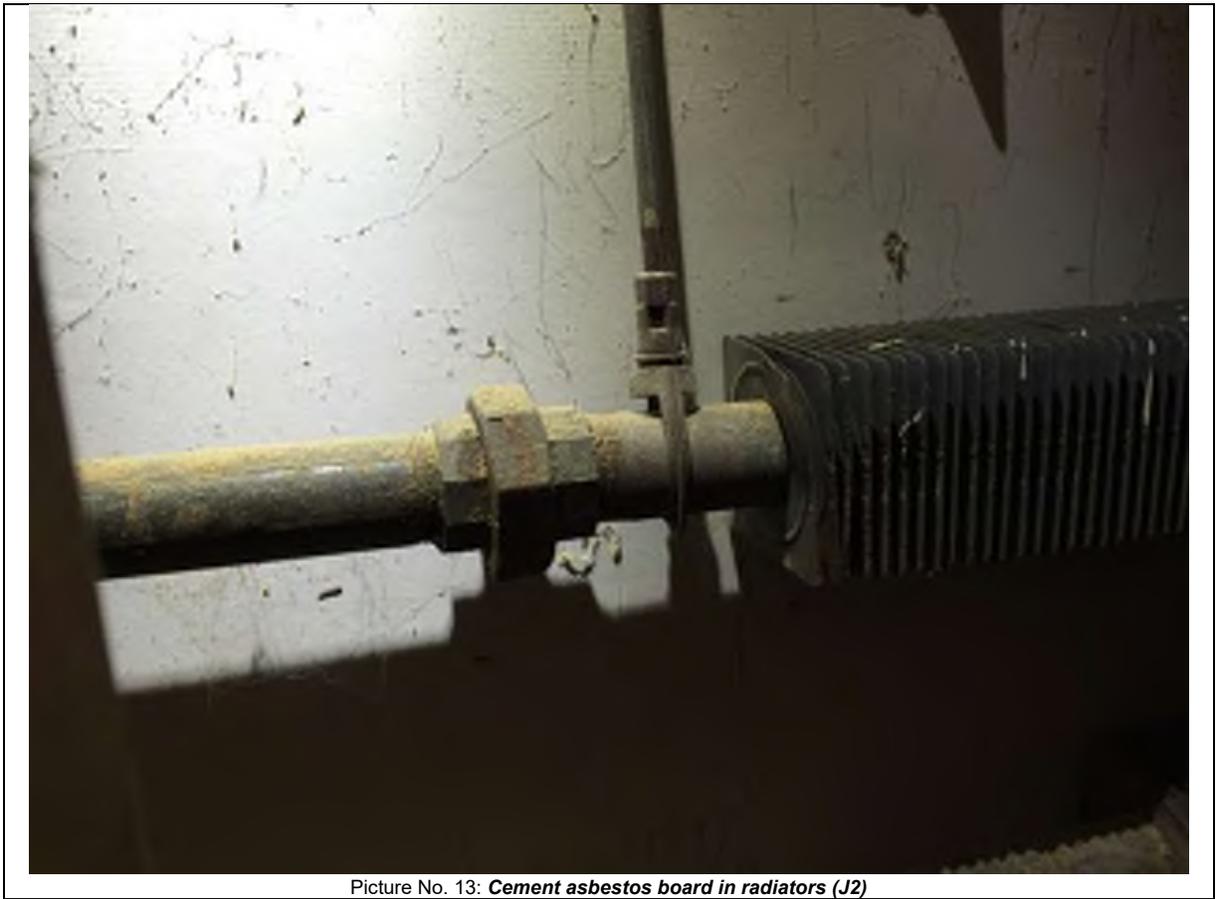
Picture No. 13: Cement asbestos board in radiators (J2)

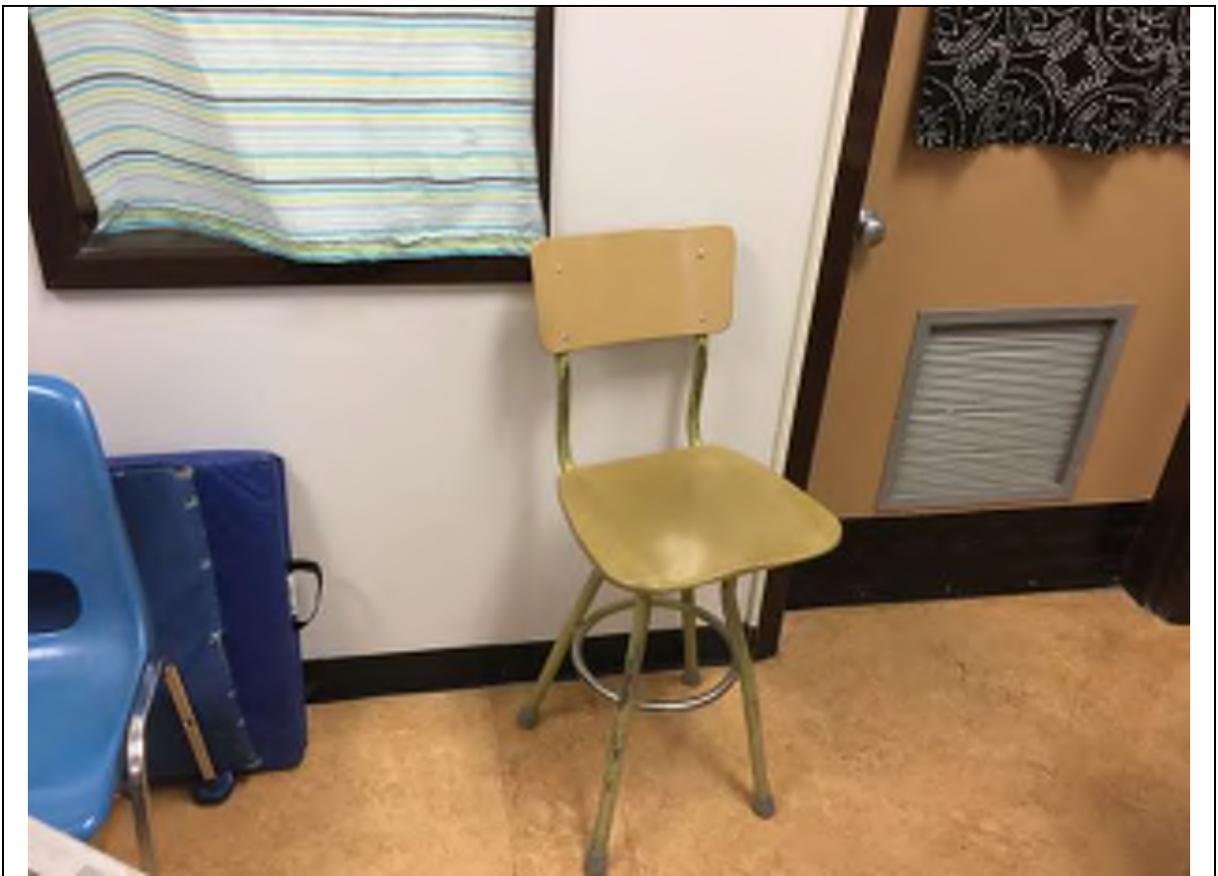
Picture No. 16: *Asbestos furnishing (Jf1)*

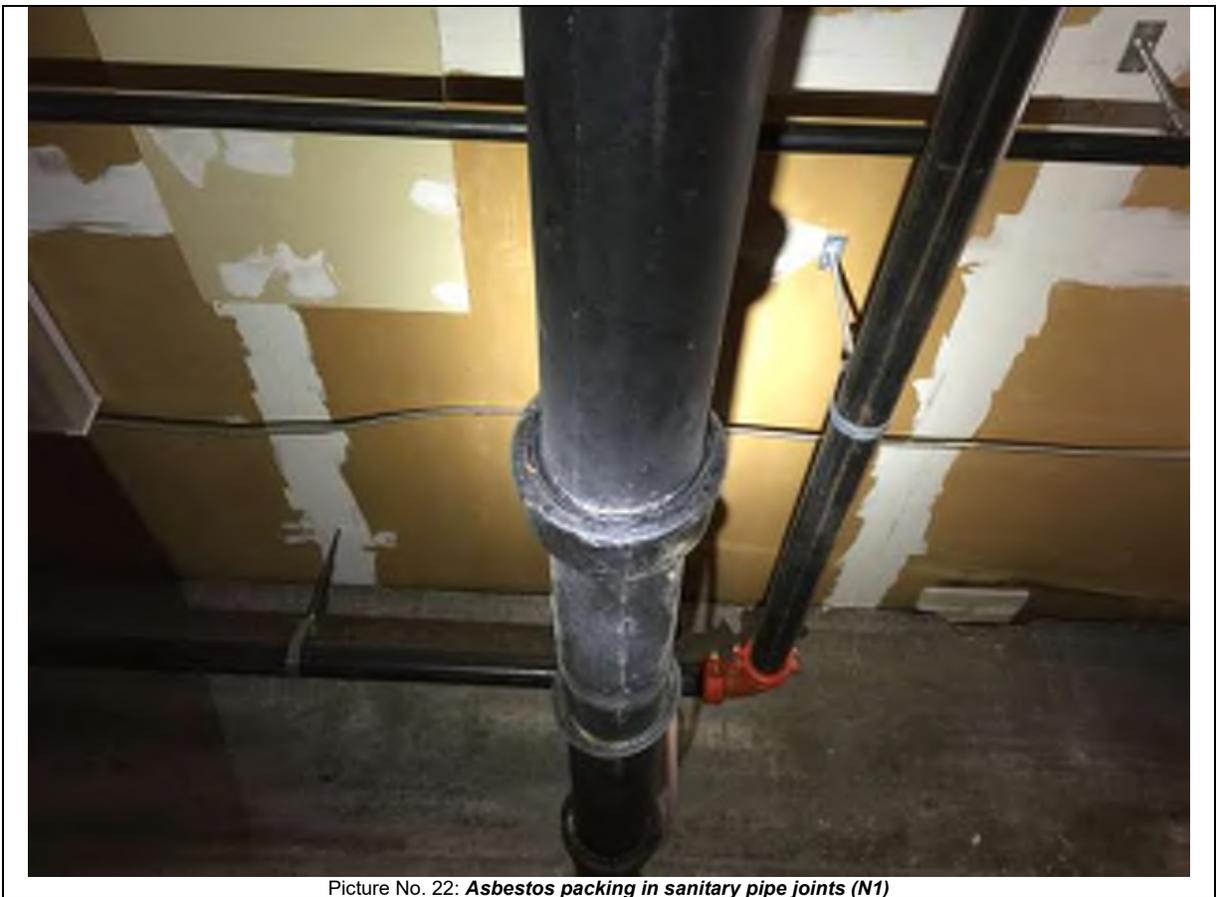
Picture No. 22: *Asbestos packing in sanitary pipe joints (N1)*

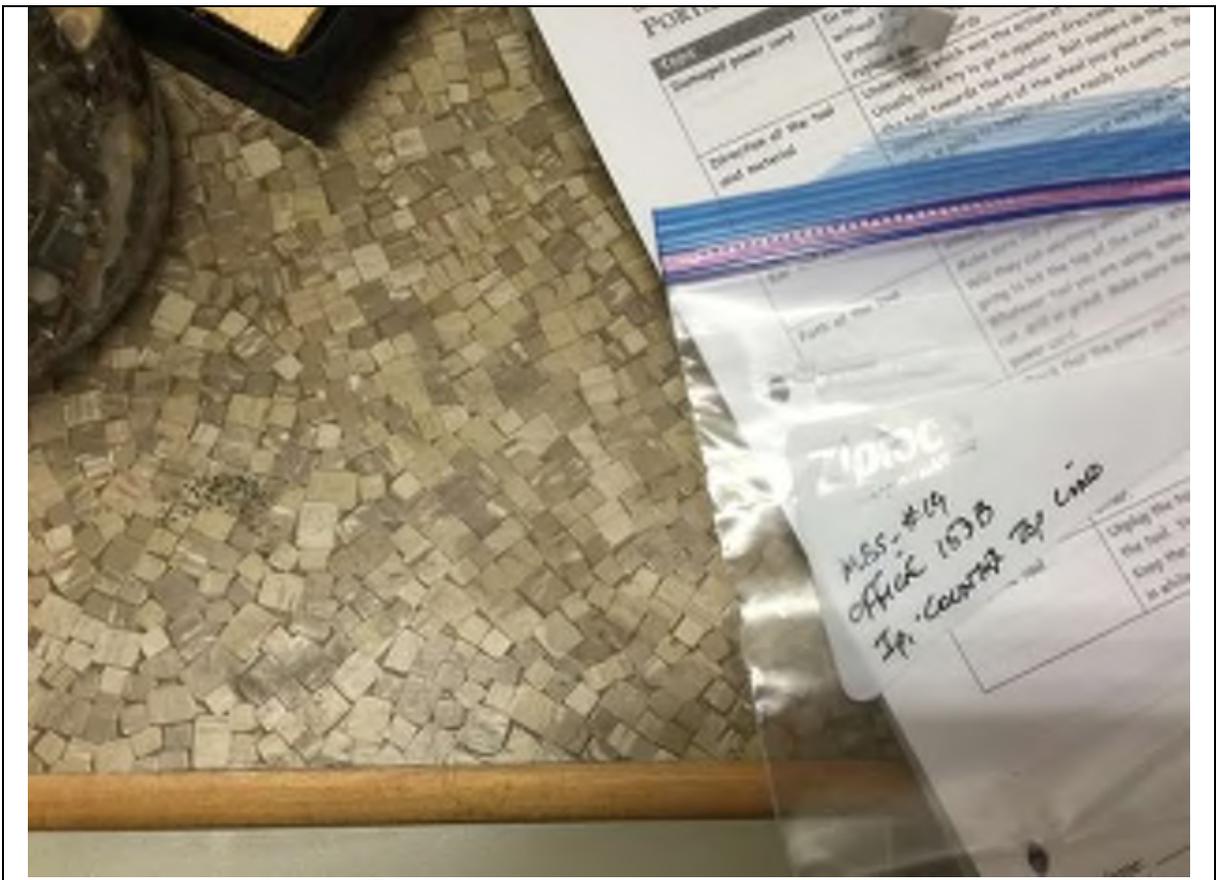
Picture No. 27: **Asbestos containing paper backed vinyl floor sheeting (lp1)**

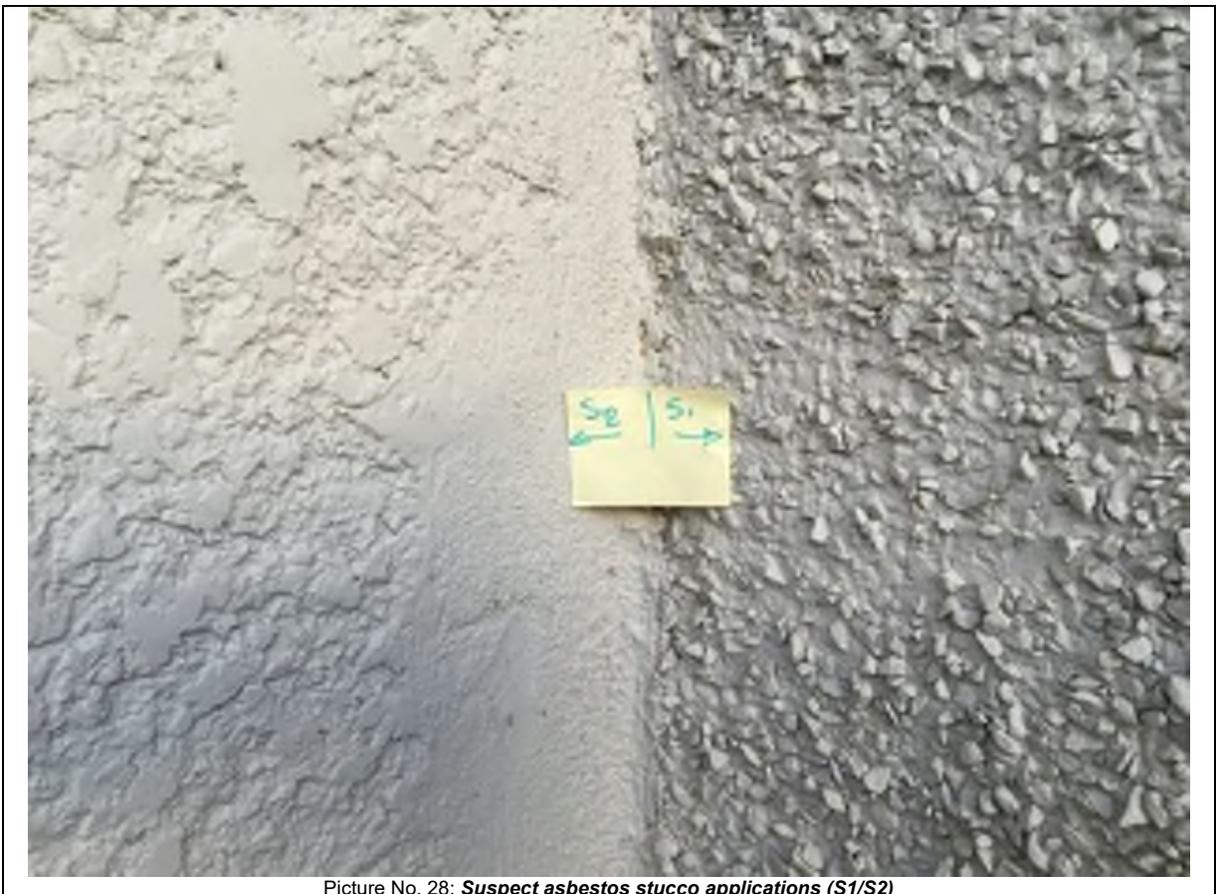
Picture No. 28: **Suspect asbestos stucco applications (S1/S2)**

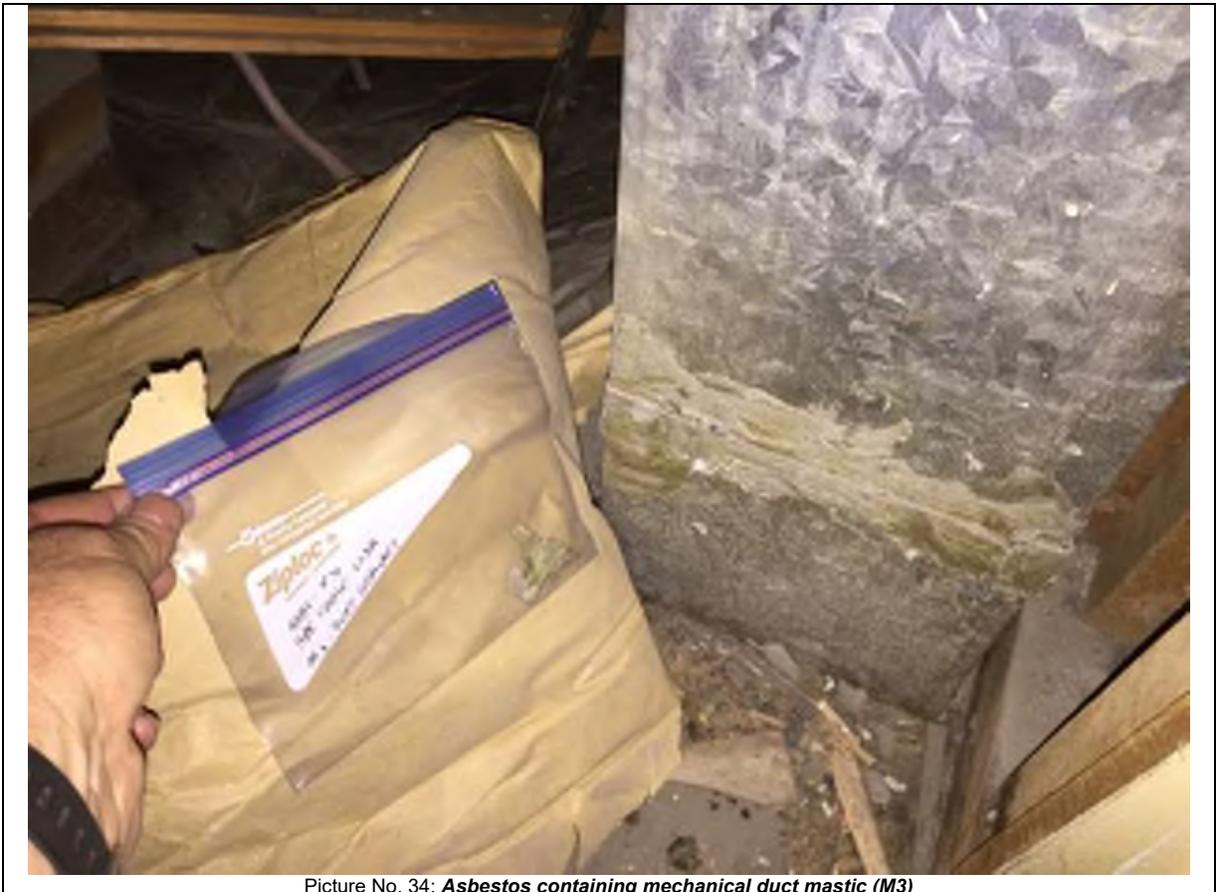
Picture No. 34: Asbestos containing mechanical duct mastic (M3)

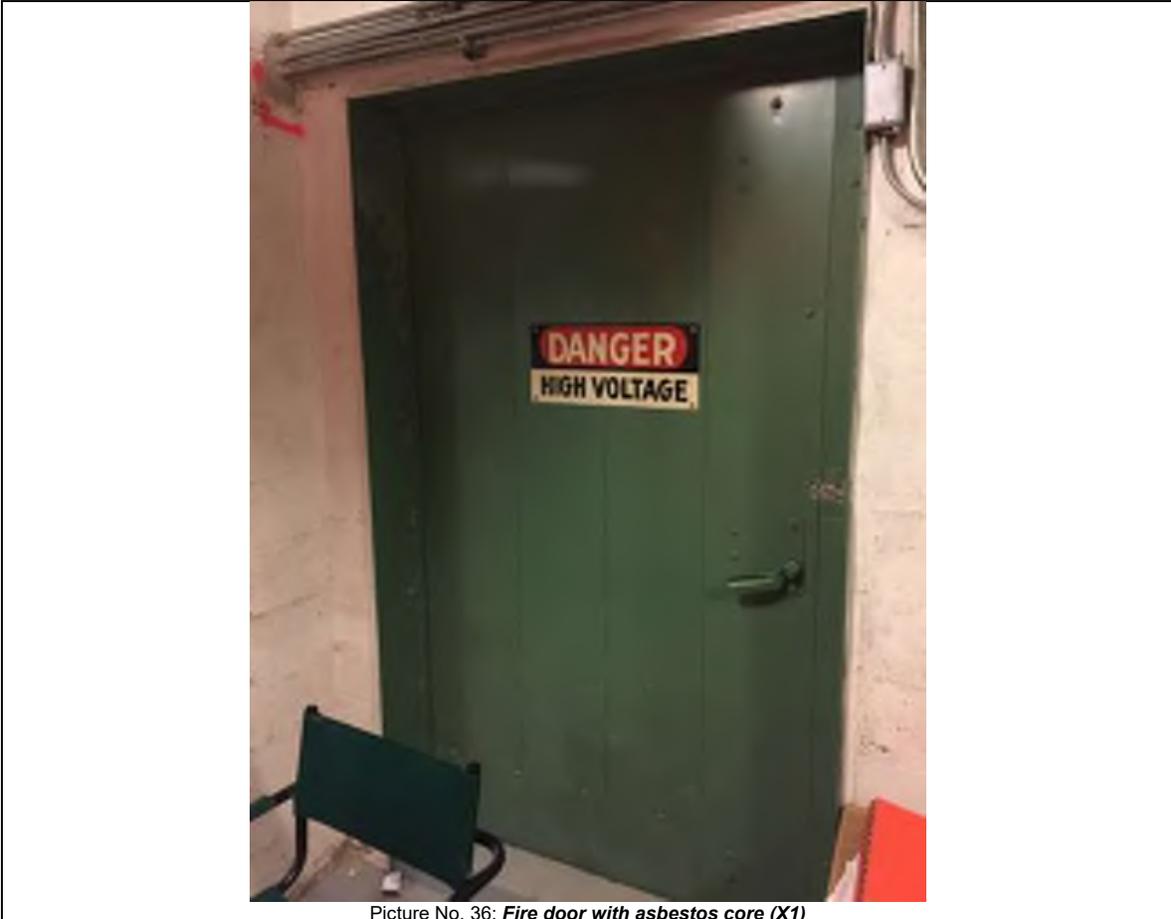
Picture No. 36: *Fire door with asbestos core (X1)*
