# School District 5 Southeast Kootenay Long Range Facilities Plan

**MOUNT BAKER SECONDARY  
SCHOOL FACILITY REVIEW**

Prepared for School District 5,  
Southeast Kootenay

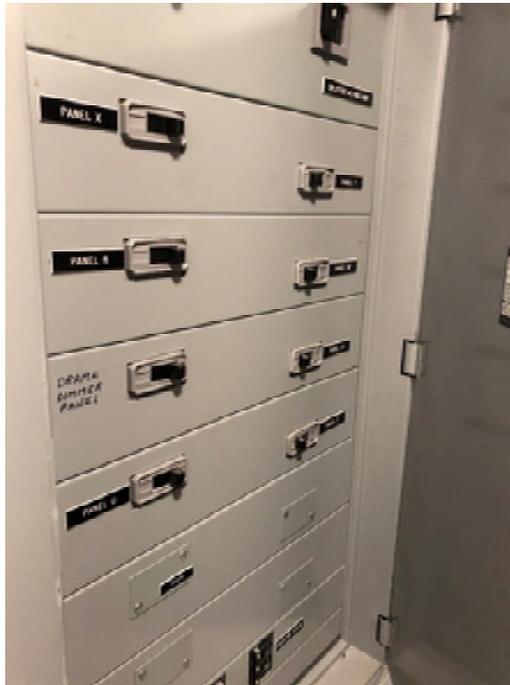
Typical Sub Distribution Centre

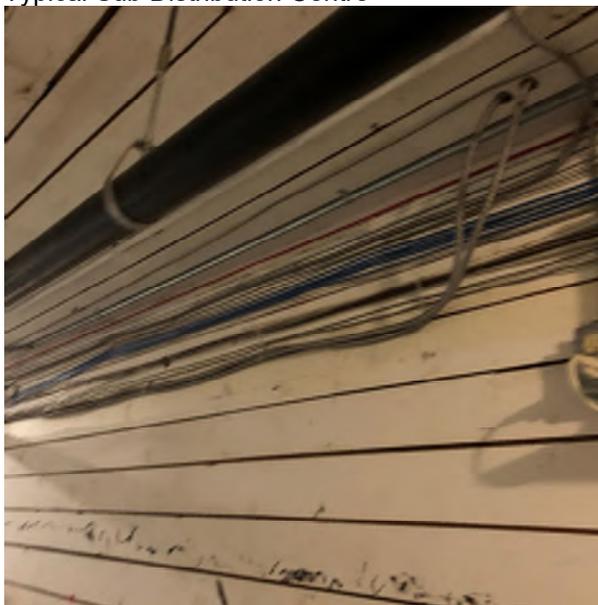
Typical Wiring Methods

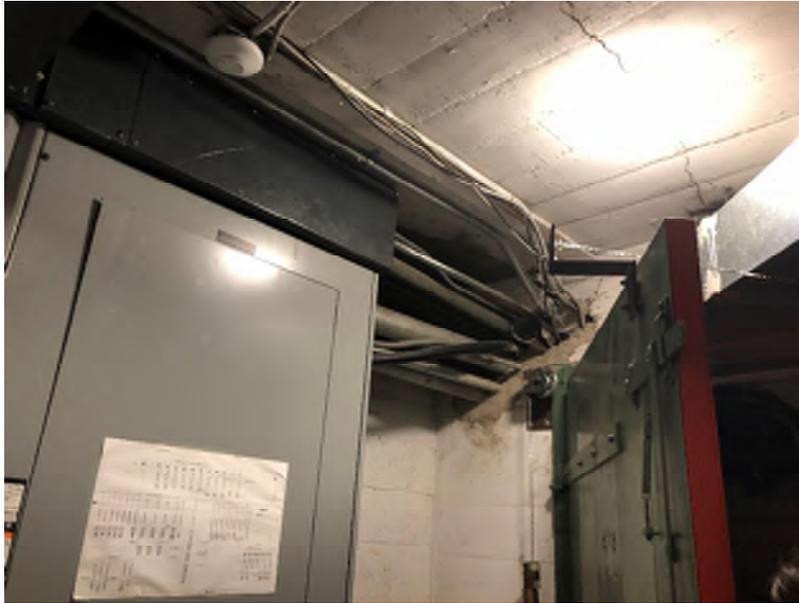
Typical Wiring without Fire Stopping

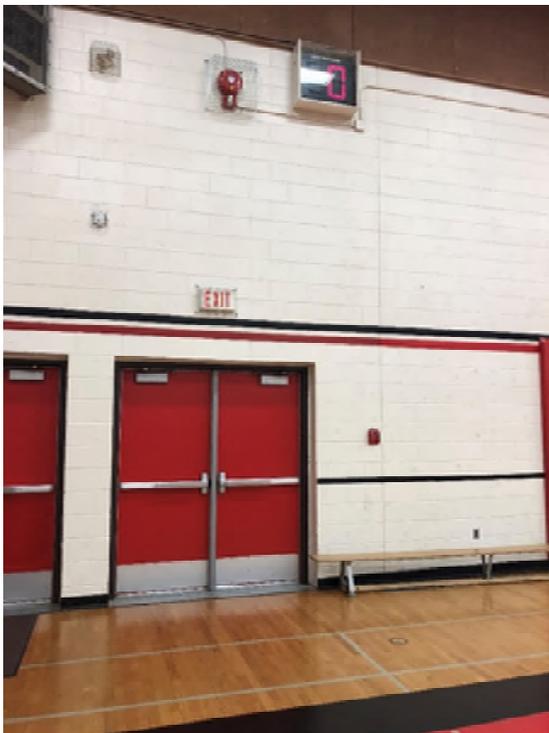
Typical Remote Head and Exit Light

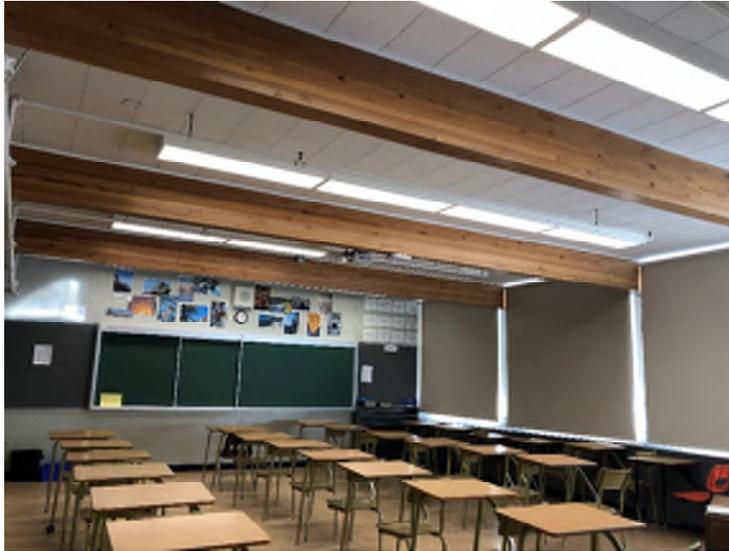
Typical Second Floor Lighting

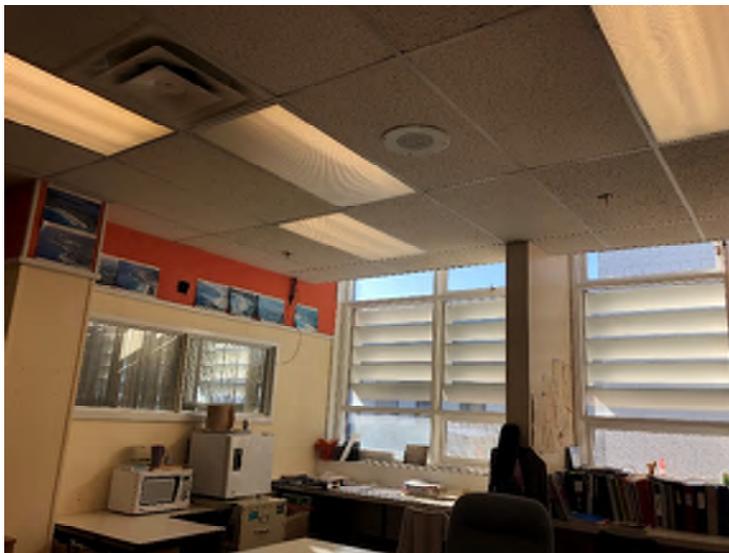
Typical Lighting

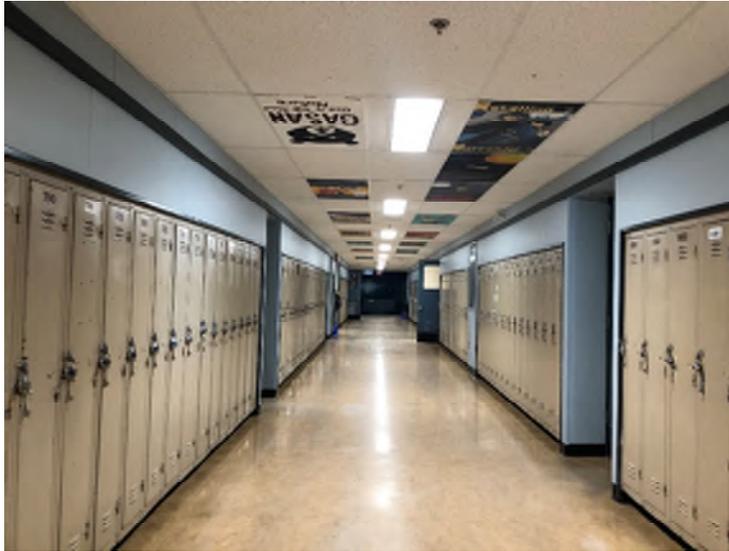
Corridor Lighting

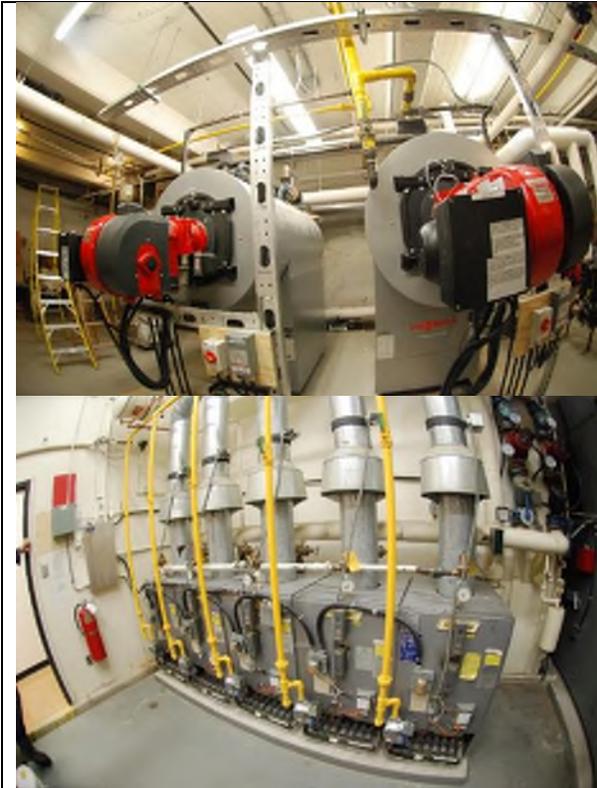
1. The primary heating is provided by two Viessmann natural gas condensing boilers that have modulating capacity control, which serve perimeter heating coils and wall fin units.

1. The Hydrotherm boilers serving the gym area are being replaced with new high efficiency boilers. As of the writing of this report, this project is in progress.
2. Additional boilers will be required to meet the outside air heating demand of the proposed system.

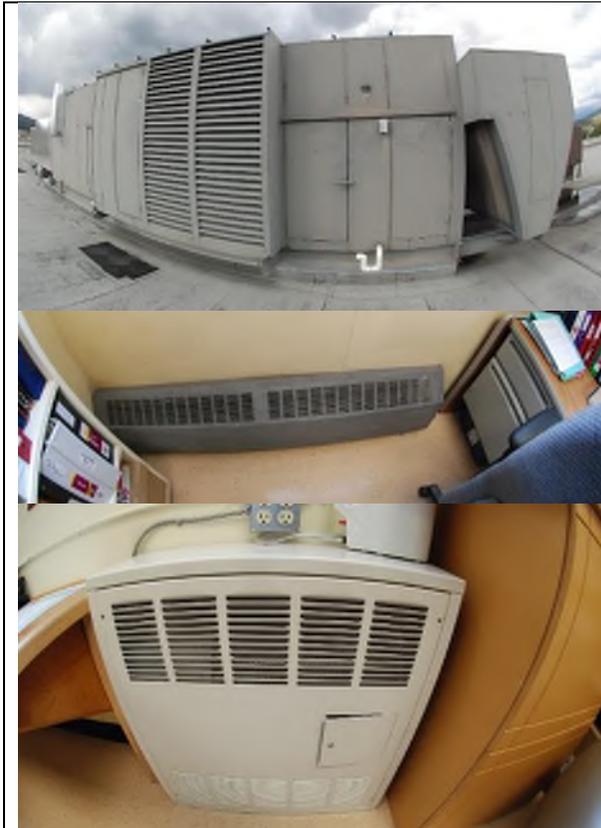
1. The bulk of the occupied zones are served by Engineered Air gas fired, electrically cooled roof top units, which provide outside air as well as some heating and cooling.

1. These systems will need to be upgraded in order to improve comfort and energy efficiency.
2. A combination of vertical unit ventilators, fan coil units, and dedicated outdoor air systems should be provided. Larger zones should be served by separate air handling systems.

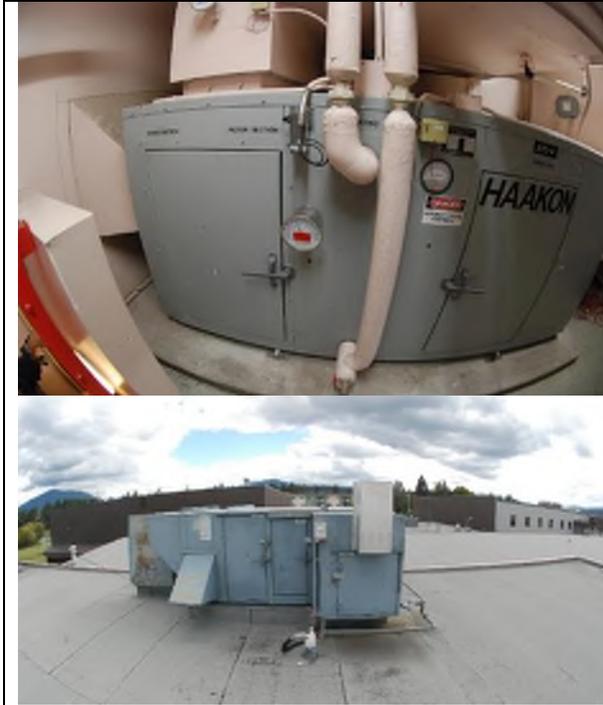
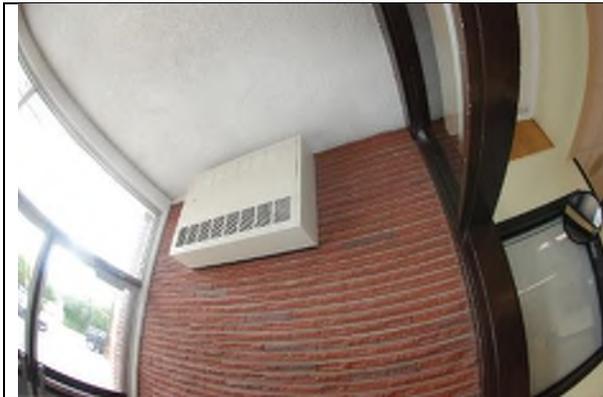
1. The terminal systems for ancillary or unoccupied areas, such as entry ways and storage rooms, are based on hydronic force flow and baseboard heating systems.
2. These systems are not compatible with modern high efficiency, low temperature heating systems.

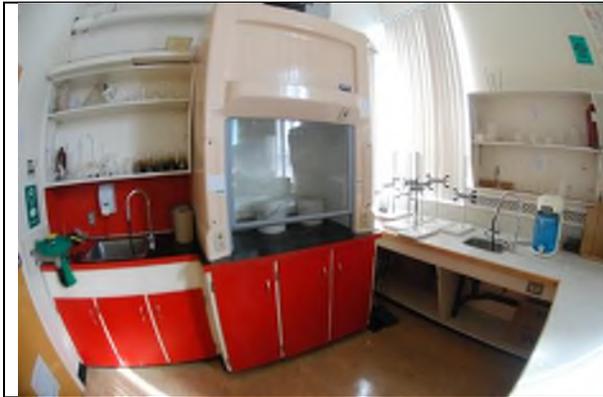
Observations:

1. Science Fume Hood – Fume hood and exhaust systems do not comply with current ASHRAE 110, WorkSafeBC Guidelines and good engineering practice.

Recommendations:

1. Fume hood exhaust systems should be upgraded.

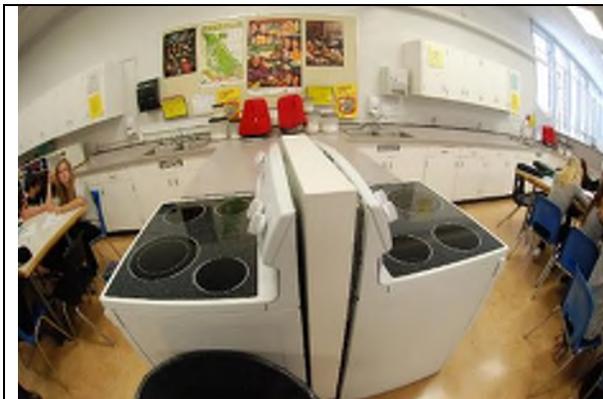
Observations:

1. Home Economics range hood exhaust systems do not comply with current good engineering practice.
2. Dilution exhaust systems have not been found to be as effective as residential style range hoods installed directly over the ranges.

Recommendations:

1. Home Economics exhaust systems should be upgraded to provide residential style hoods over each range, however this will not be practical without a major millwork upgrade. **Note that this work is outside of the present scope but should be included with a future architectural upgrade.**

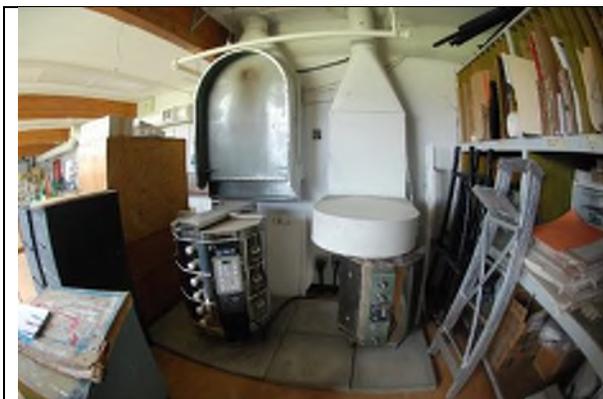
Observations:

1. Art Room kiln exhaust systems do not comply with current good engineering practice. Slot style exhaust hoods provide better source capture and control of odours and contaminants.
2. One of the kiln exhaust hoods will not lower into place due to interference from a sprinkler pipe.
3. The kiln exhaust system is in "critical" condition.

Recommendations:

1. Provide a slot style exhaust hood behind the kiln and enclose the kiln in a new dedicated room to contain odours. **Note that this work is outside of the present scope but should be included with a future architectural upgrade.**

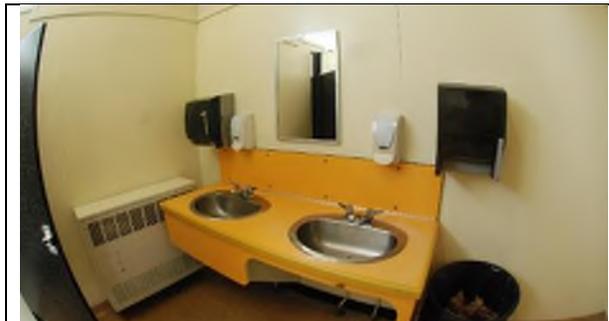
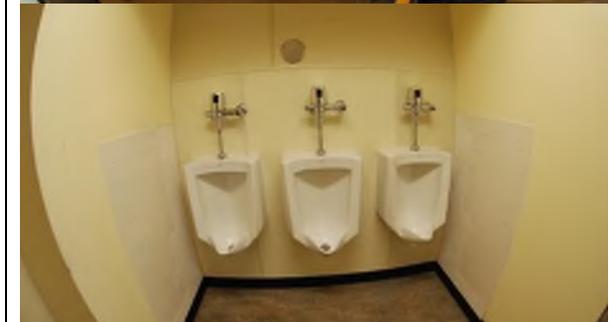
<p>Observations:</p> <ol style="list-style-type: none"> <li>1. Most plumbing fixtures have been upgraded as required.</li> <li>2. Hand lavatories have not been provided with the hands-free fixtures.</li> </ol>

<p>Recommendations:</p> <ol style="list-style-type: none"> <li>1. Manual lavatory faucets should be replaced with hands-free units to reduce water consumption and improve hygiene.</li> </ol>

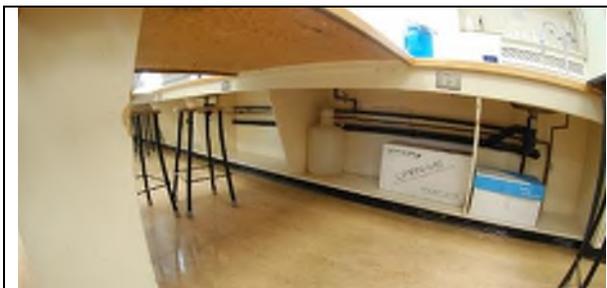
Observations:

1. Acid waste piping has not been installed on Science Room sanitary drainage systems.

Recommendations:

1. Provide under sink acid neutralizers to serve each Science Room sink.

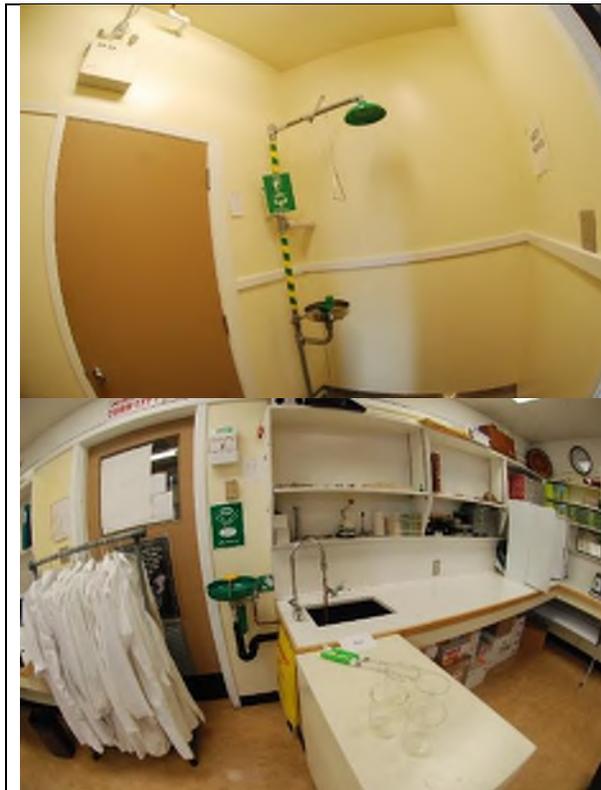
### Observations:

1. Emergency eyewashes and showers with companion water tempering systems, which are plumbed into the domestic water systems to meet current Code requirements, have not been provided for the Shop, Science Labs, or Science Prep Room.
2. An emergency eyewash and shower has been provided off a corridor near the Science Rooms, but it is behind a locked door and is not considered accessible.
3. These systems are in "critical" condition.

### Recommendations:

1. Emergency eyewashes and showers should be provided in each Science Room, Wood Shop, Metal Shop, Automotive Shop and Science Prep Room.

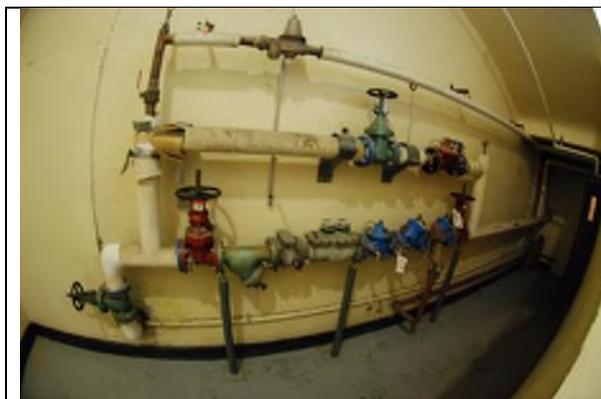
### Observations:

1. Cross contamination and premise isolation devices have not been provided on water service and sprinkler stations, which are typically required by most municipalities.
2. A bypass is present that will allow water to circumvent the backflow preventer. This does not comply with current codes. This condition is considered "critical".

### Recommendations:

1. These systems should be upgraded. The Dual Check Valve Assembly should be relocated to downstream of the bypass.

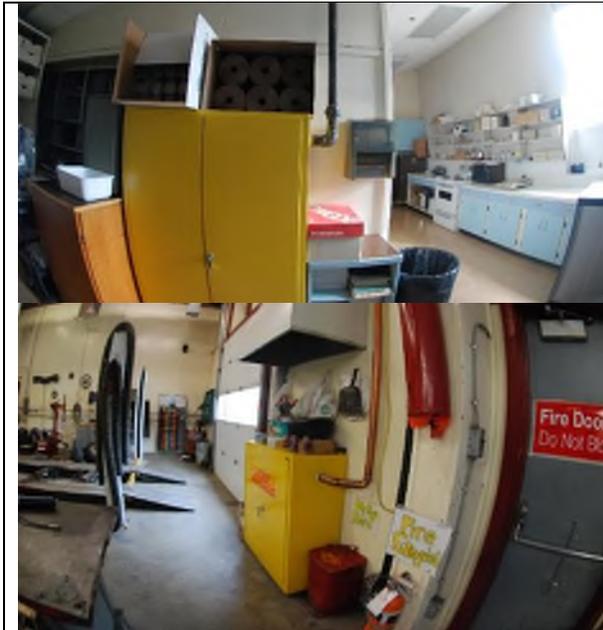
Observations:

- ◆ A flammable storage cabinet in the Science Prep Room has been vented according to manufacturers and WorkSafeBC Guidelines, however the cabinet in the Automotive Shop has not.

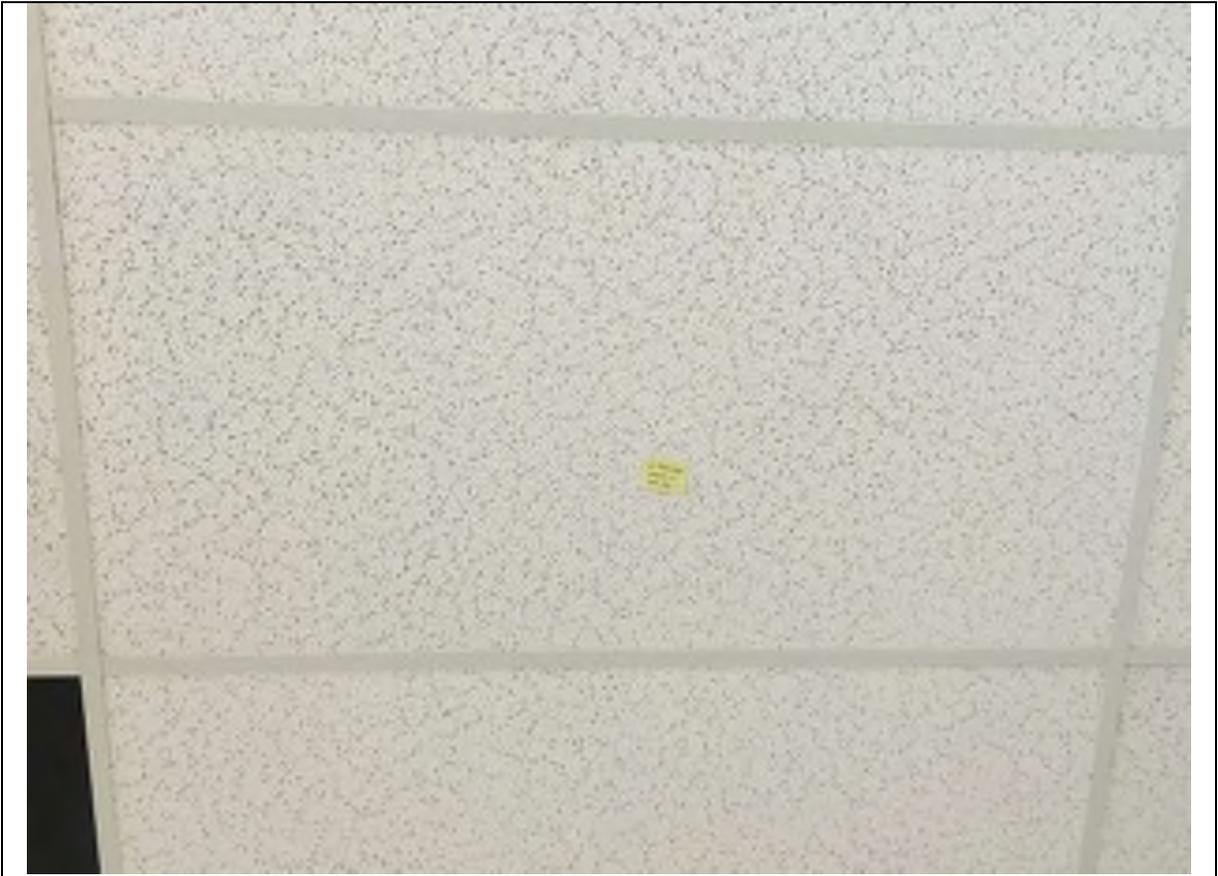
Picture No. 1: Non asbestos ceiling tiles

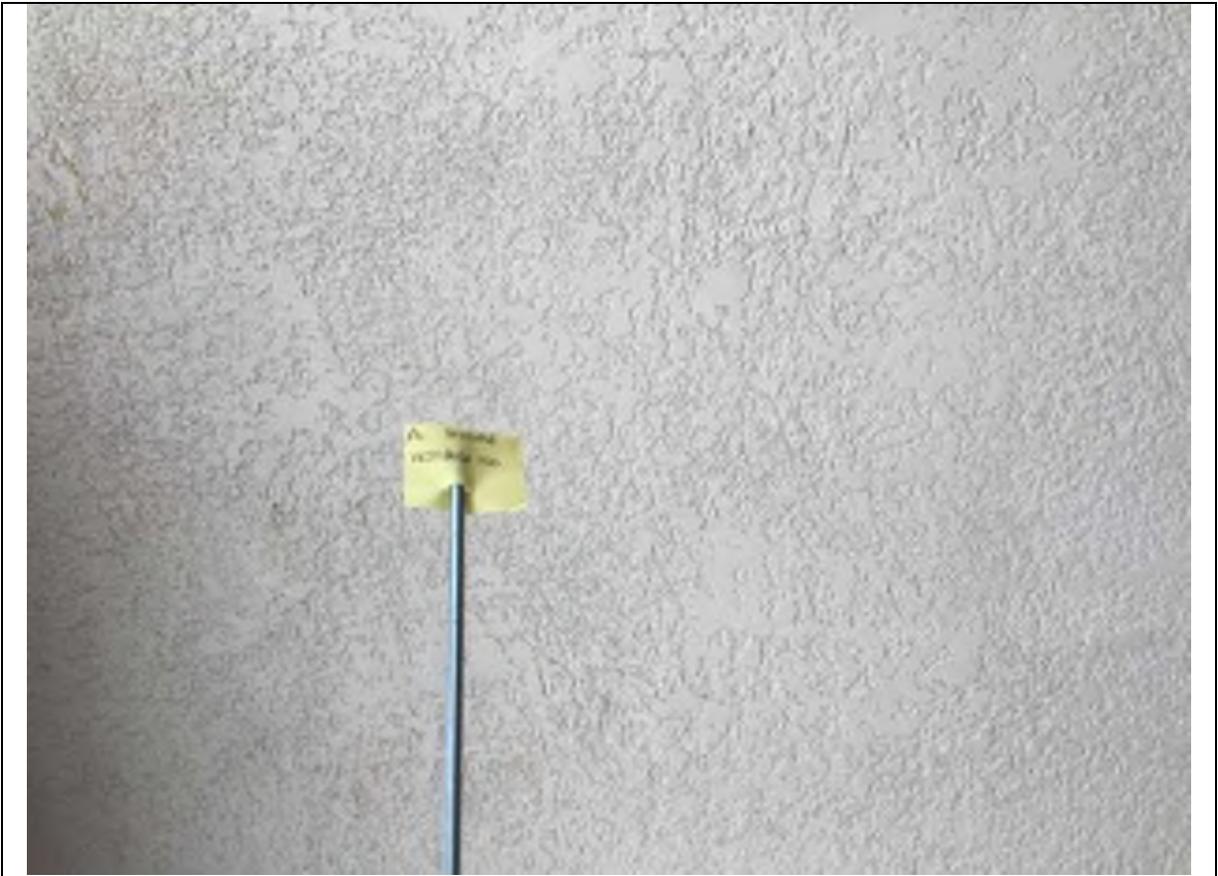
Picture No. 2: Non asbestos ceiling texture

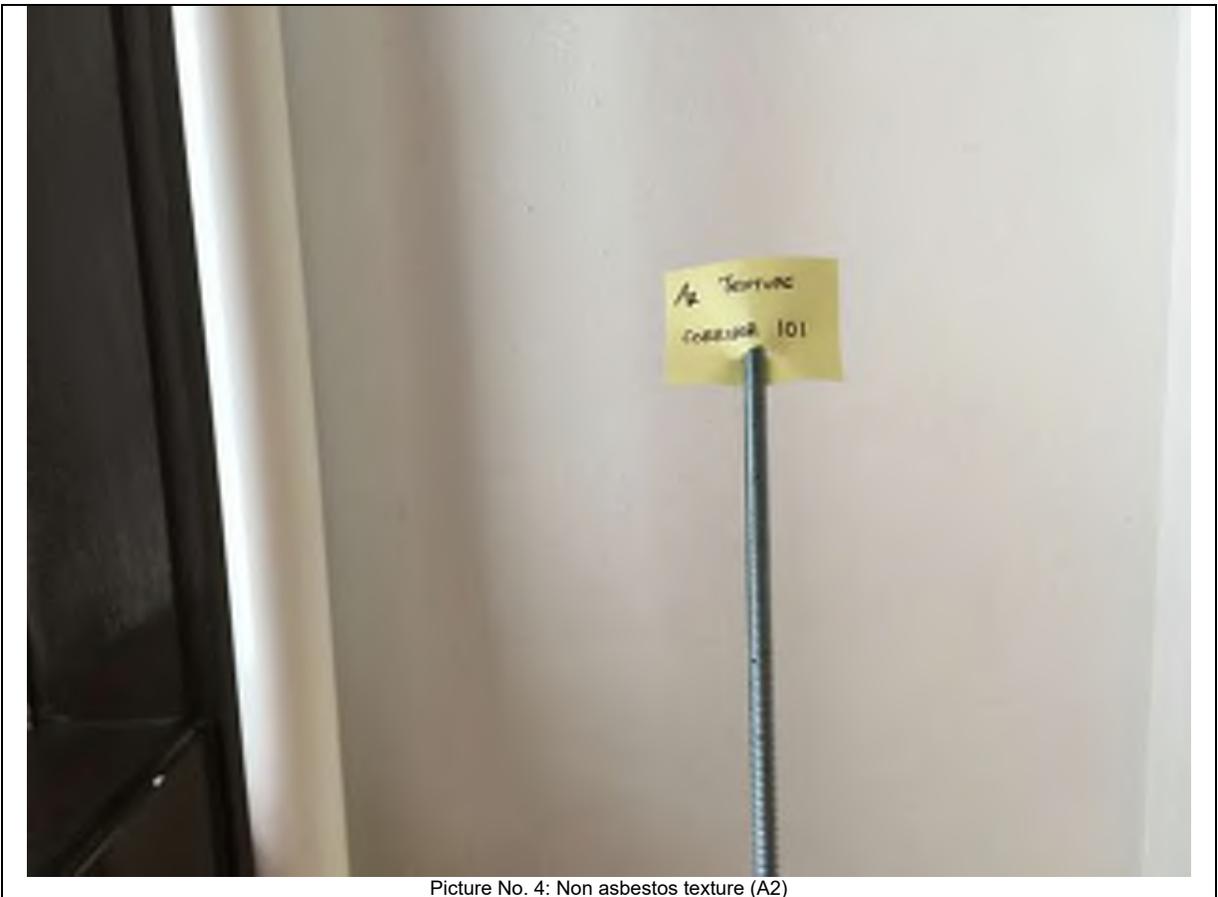
Picture No. 4: Non asbestos texture (A2)

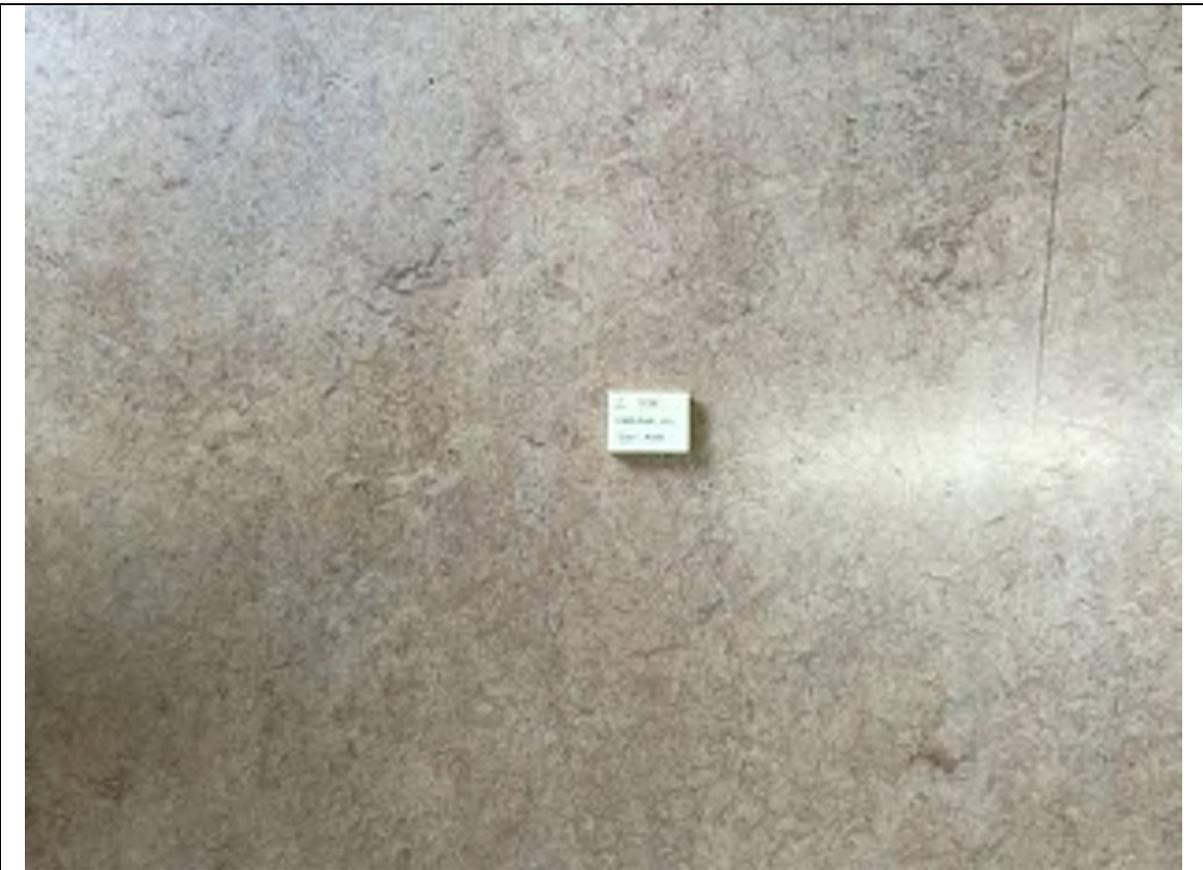
Picture No. 5: Non asbestos vinyl floor sheeting (I1)

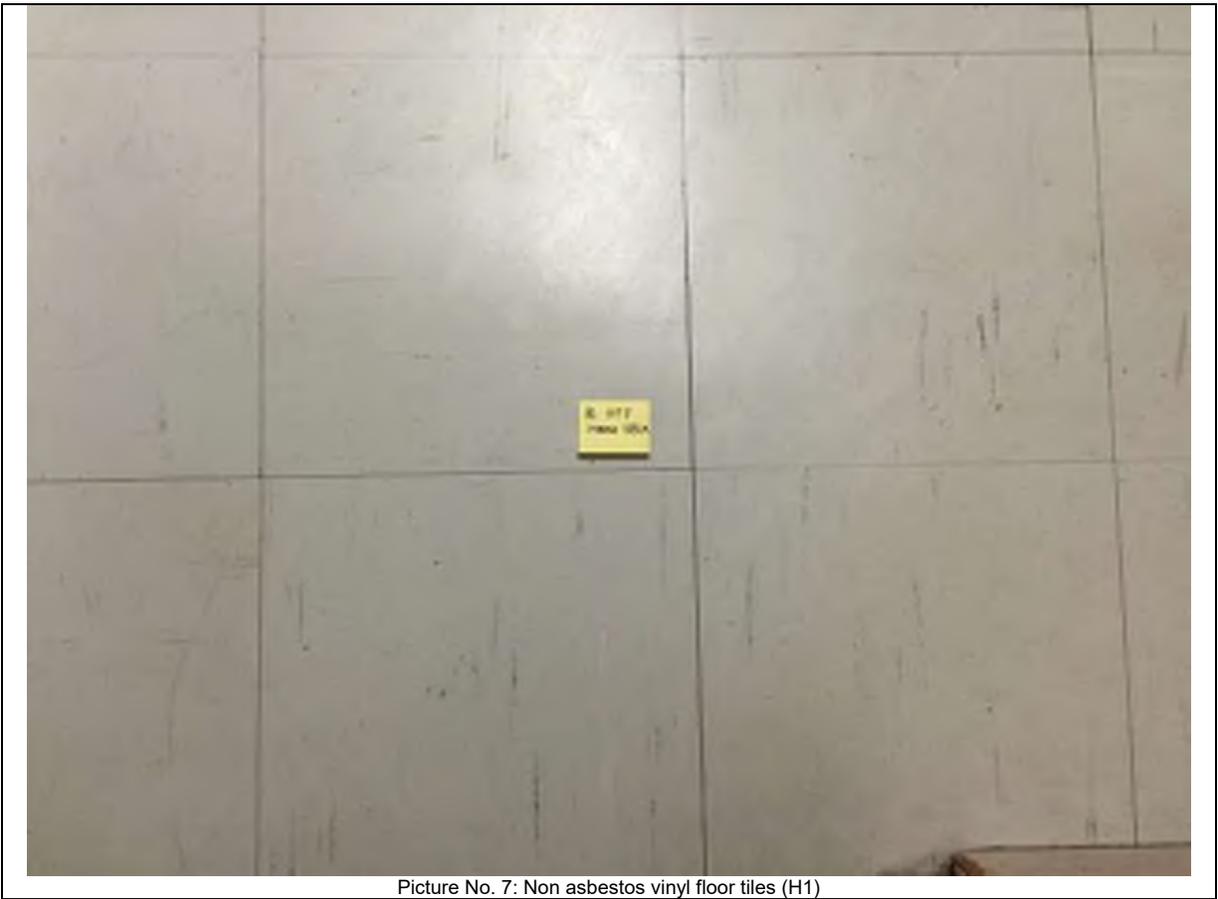
Picture No. 7: Non asbestos vinyl floor tiles (H1)

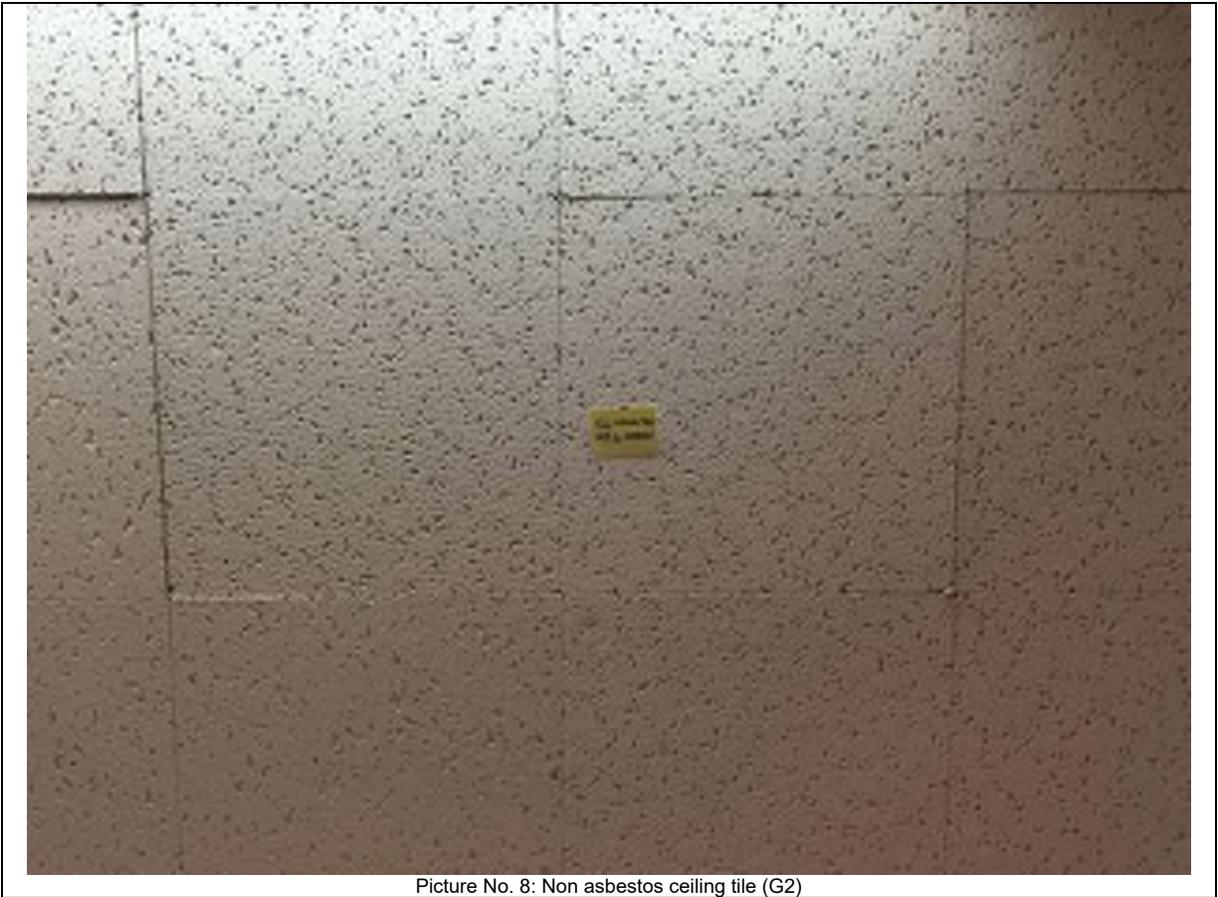
Picture No. 8: Non asbestos ceiling tile (G2)

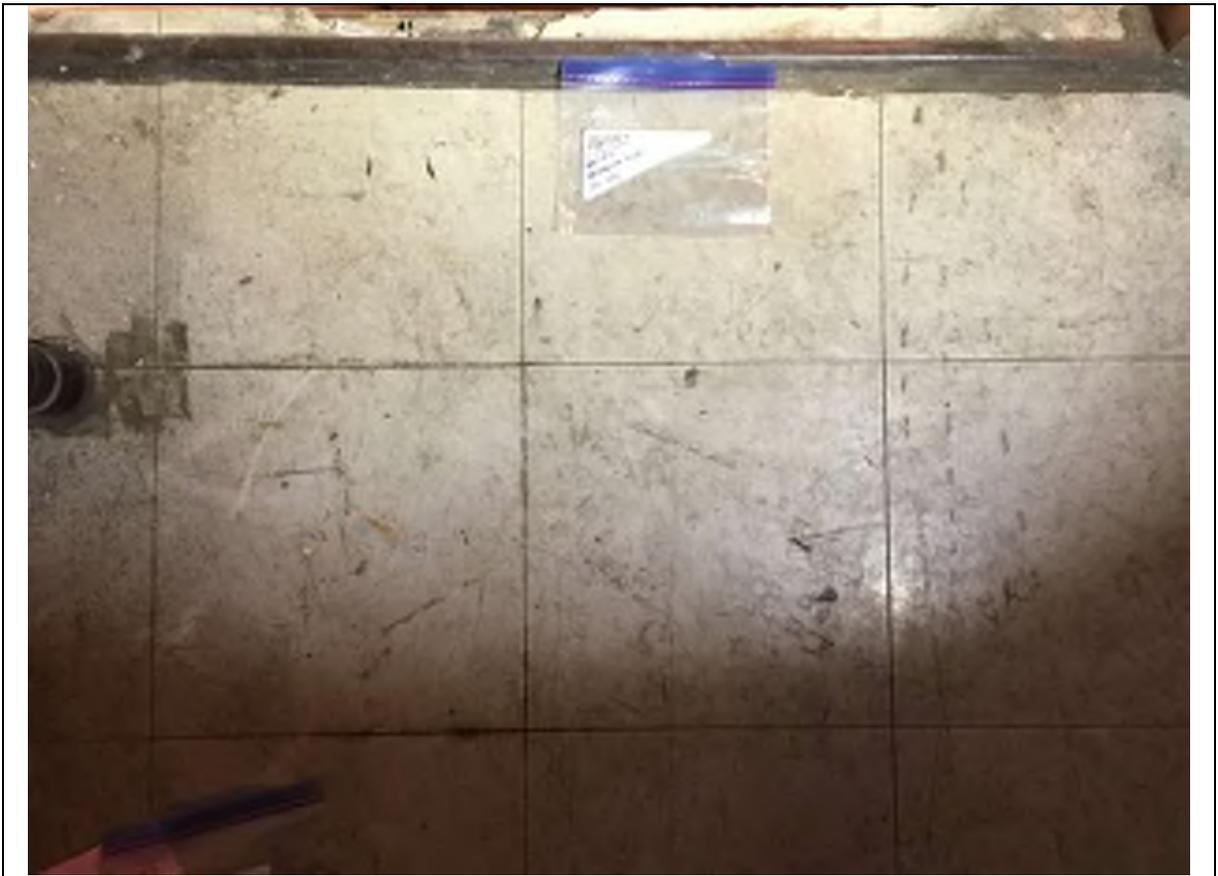
Picture No. 9: Non asbestos vinyl floor tiles (H2)

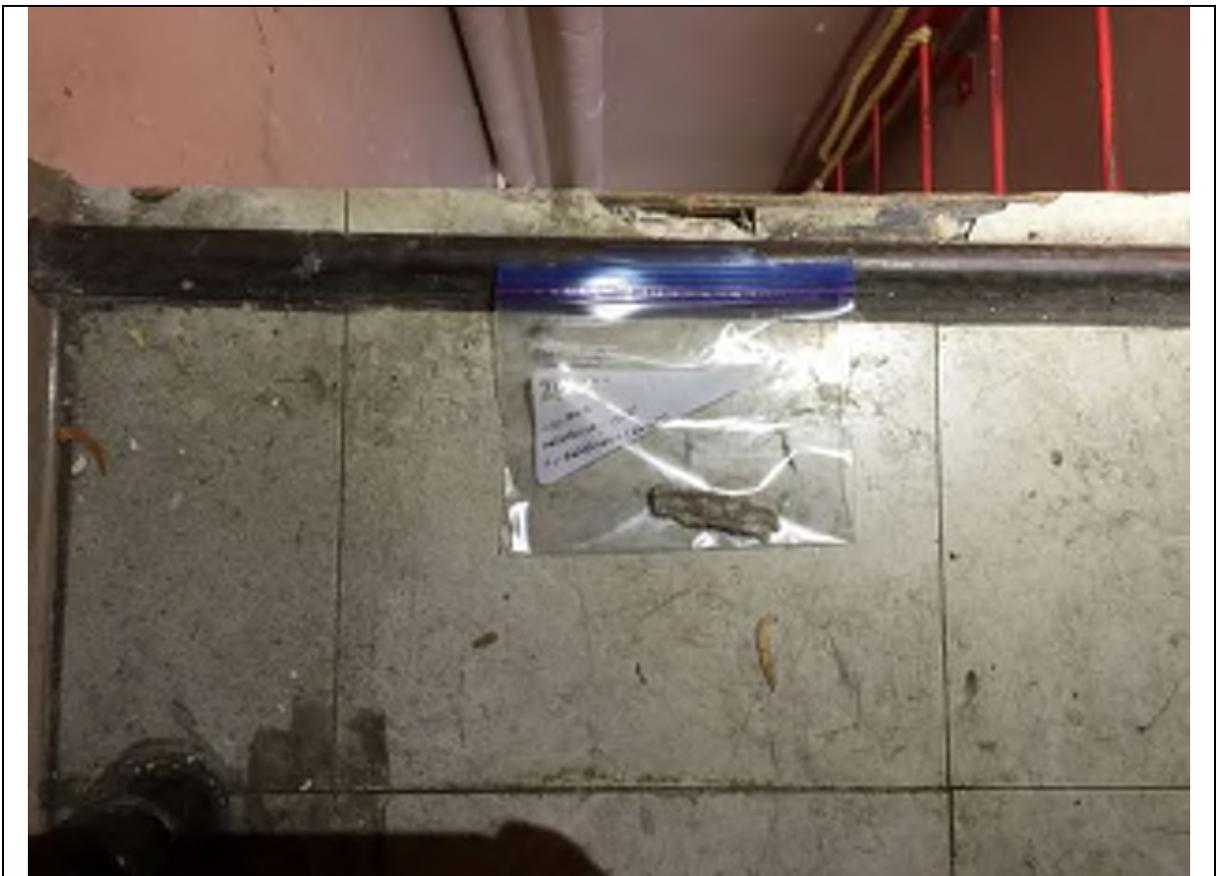
Picture No. 10: Non asbestos leveling compound beneath floor tiles (O1)

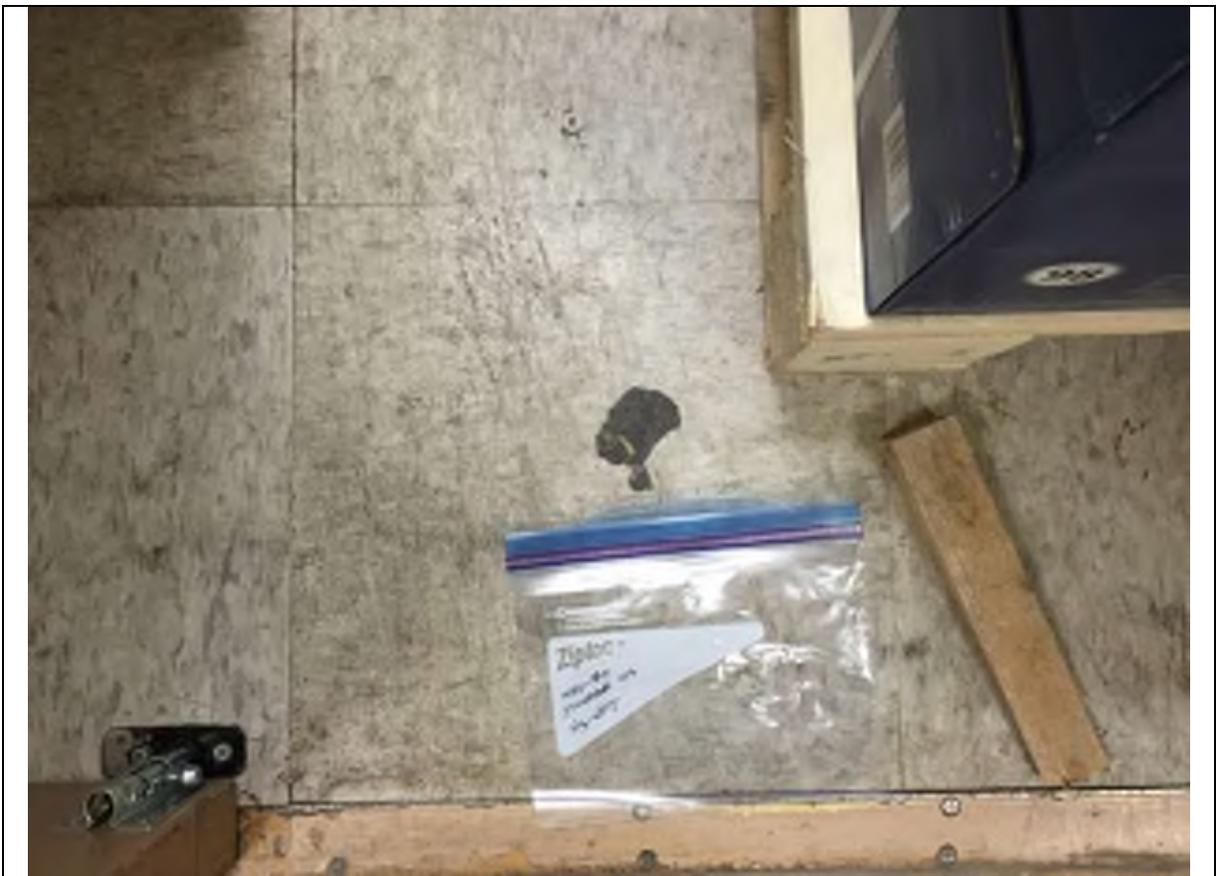
Picture No. 12: Non asbestos vinyl floor tiles (H3)

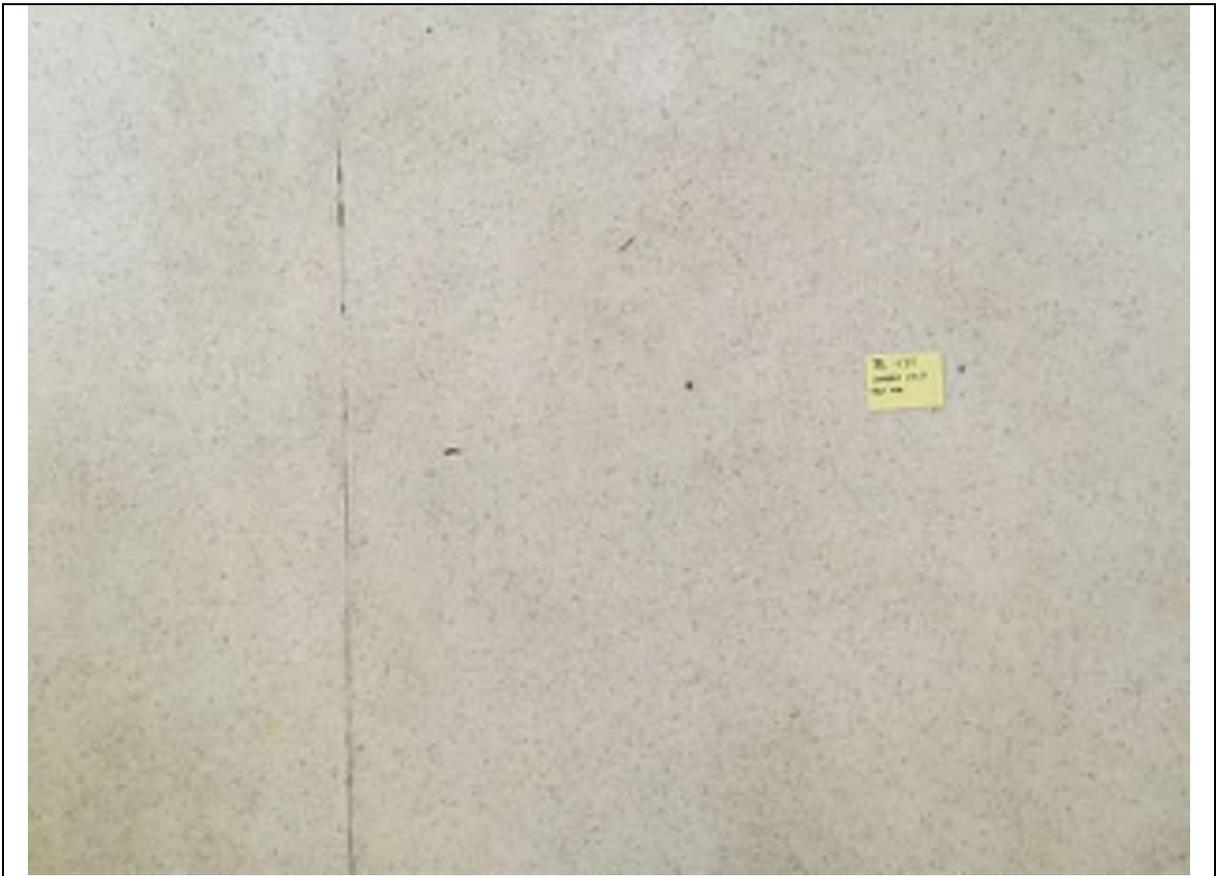
Picture No. 17: Non asbestos vinyl floor sheeting (I2)

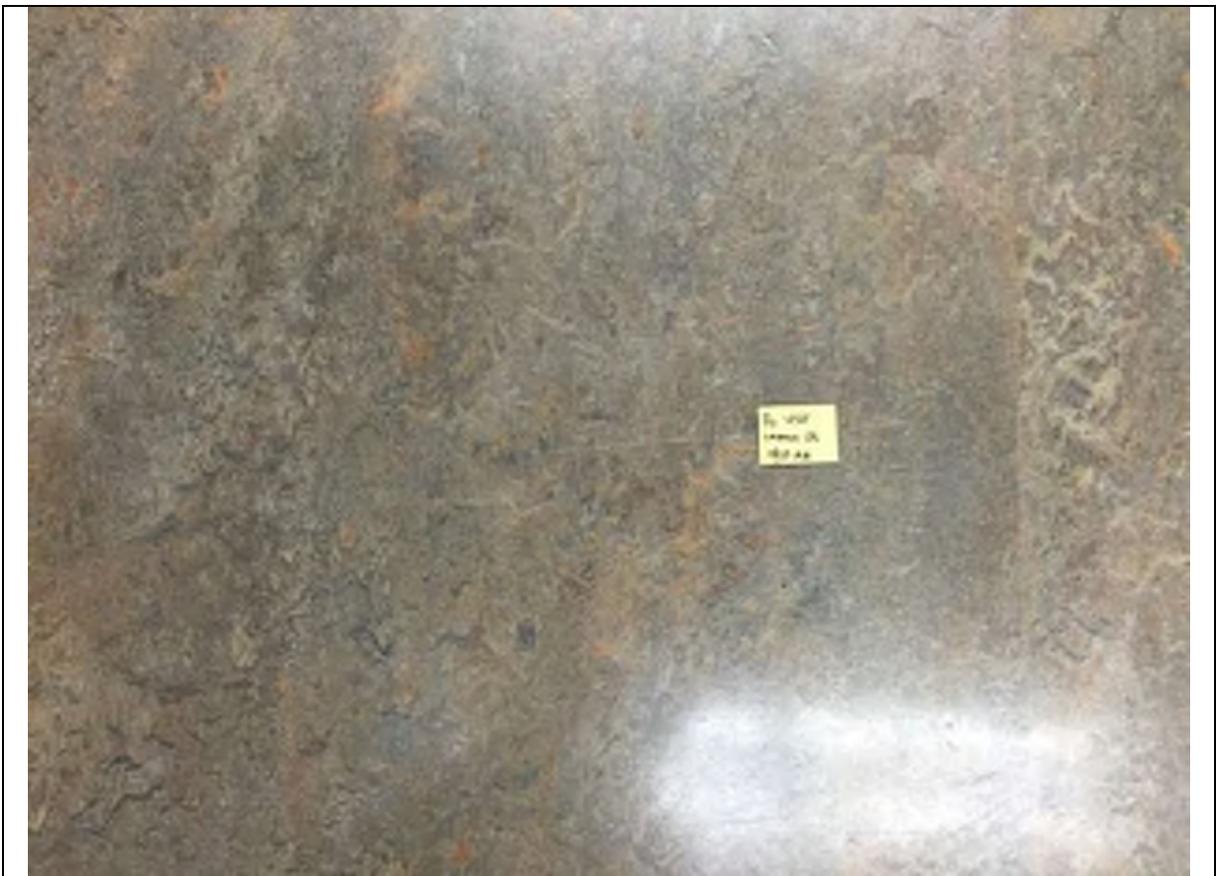
Picture No. 18: Non asbestos vinyl floor sheeting (I3)

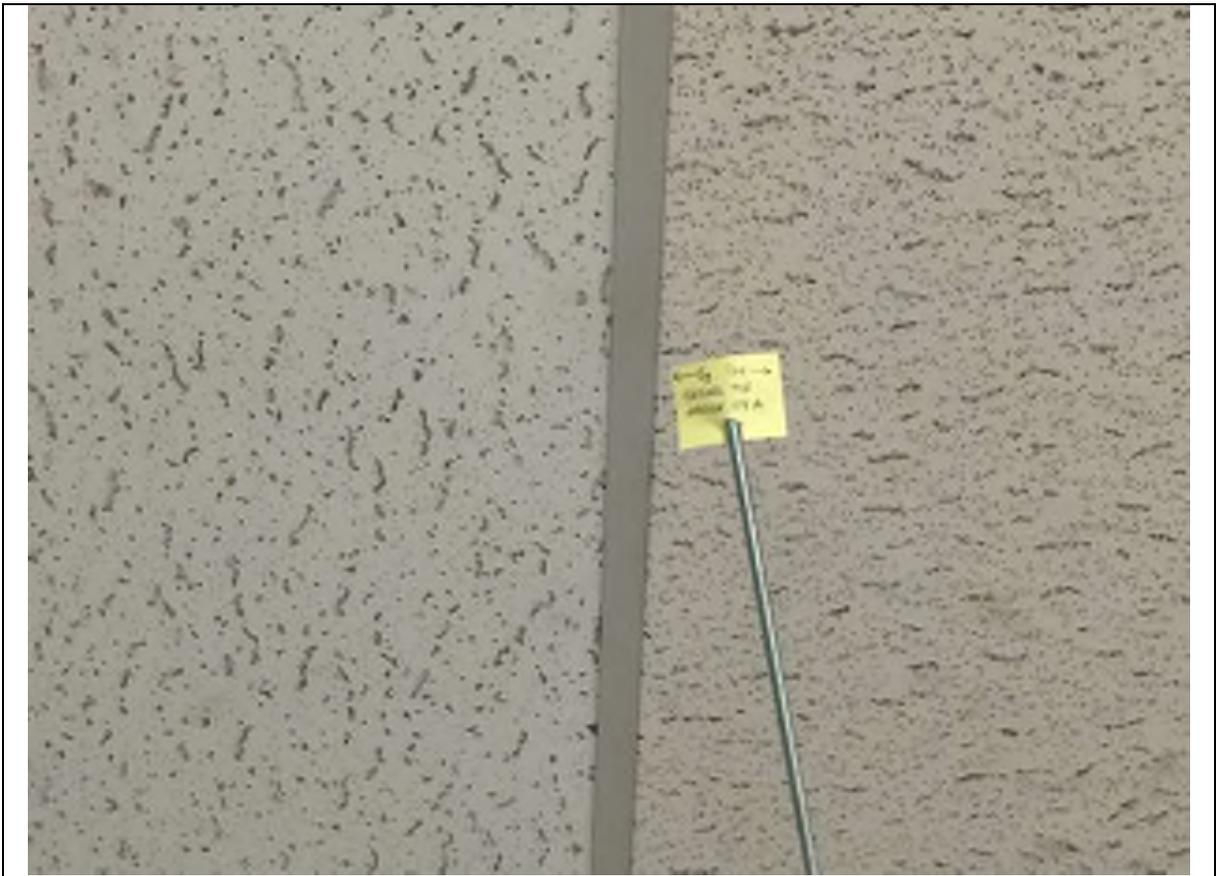
Picture No. 19: Non asbestos ceiling tiles (G3/G4)

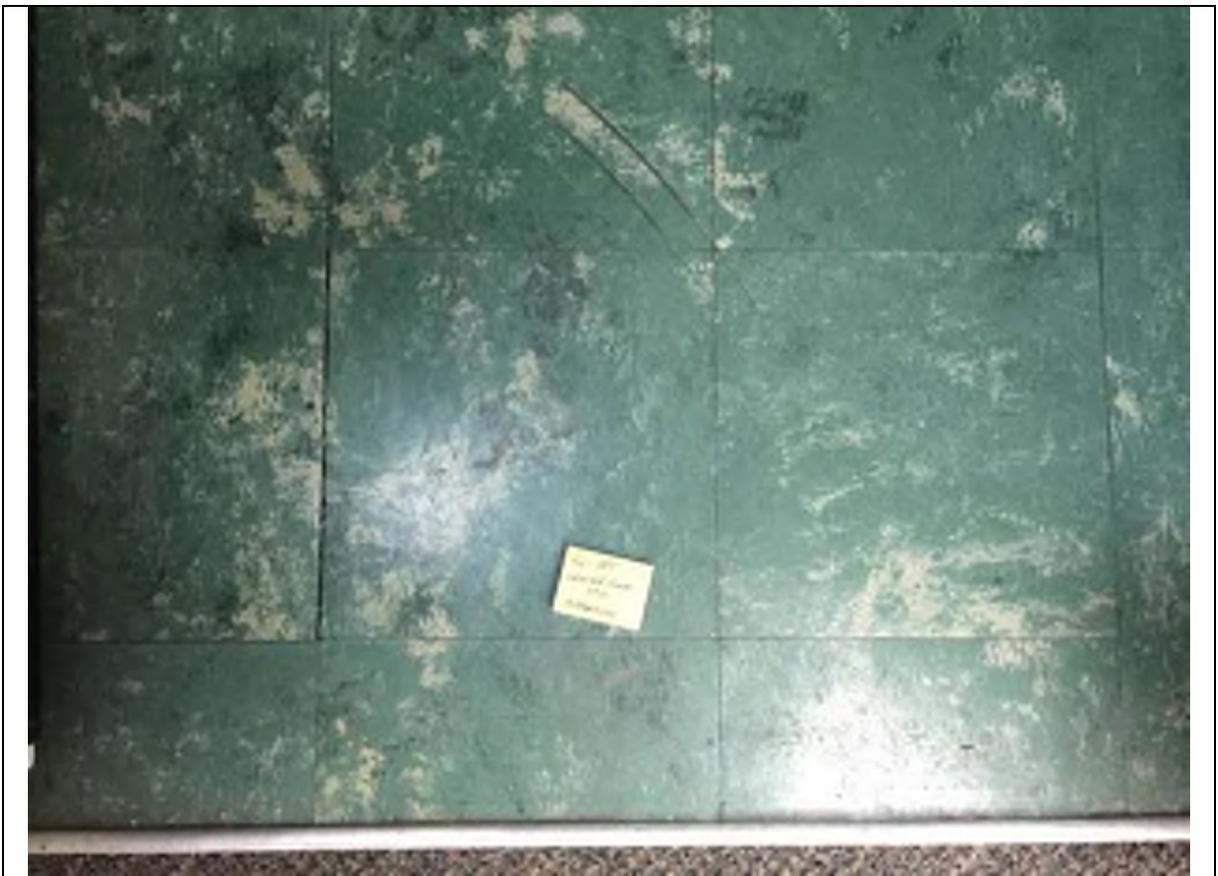
Picture No. 20: **Asbestos containing vinyl floor tiles (H4)**
