# School District 5 Southeast Kootenay Long Range Facilities Plan

**MOUNT BAKER SECONDARY  
SCHOOL FACILITY REVIEW**

Prepared for School District 5,  
Southeast Kootenay

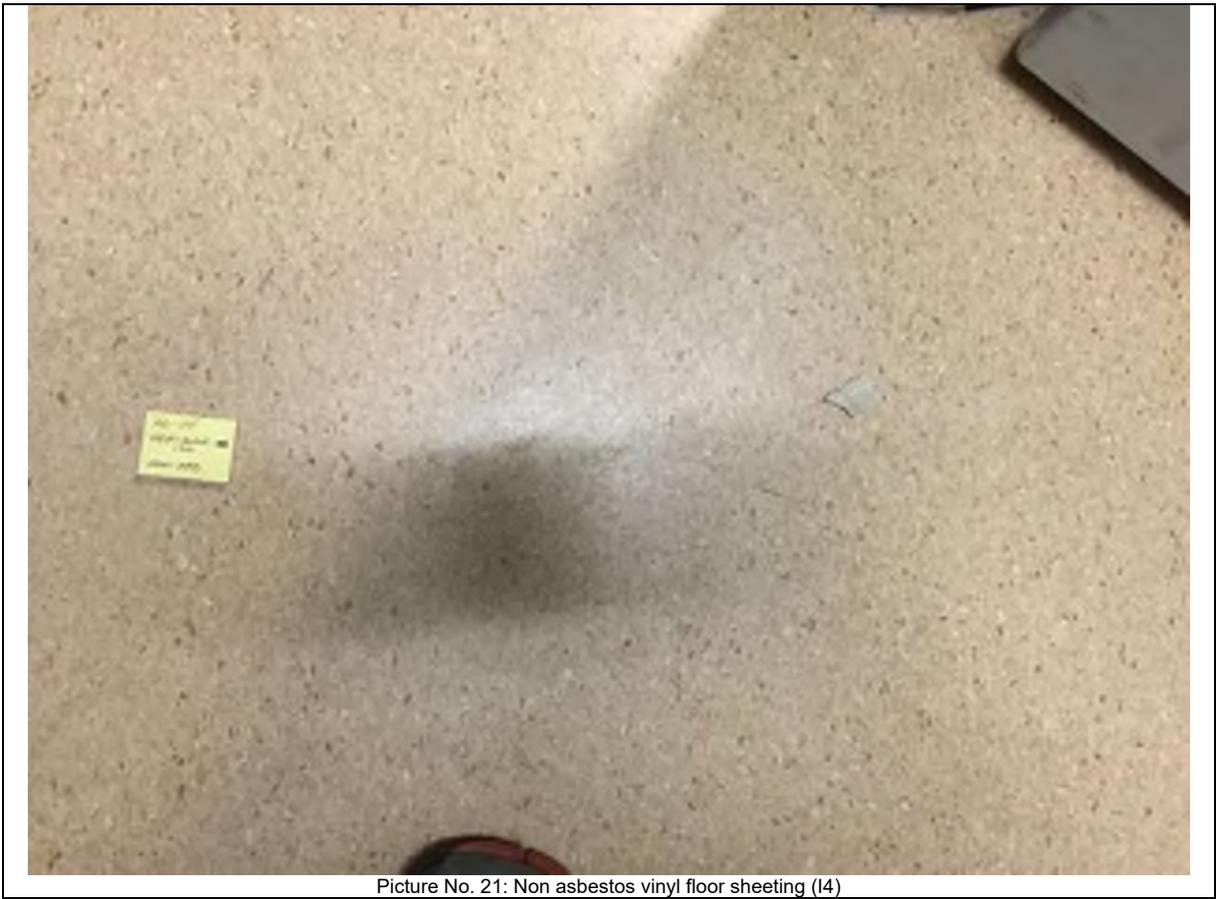
Picture No. 21: Non asbestos vinyl floor sheeting (I4)

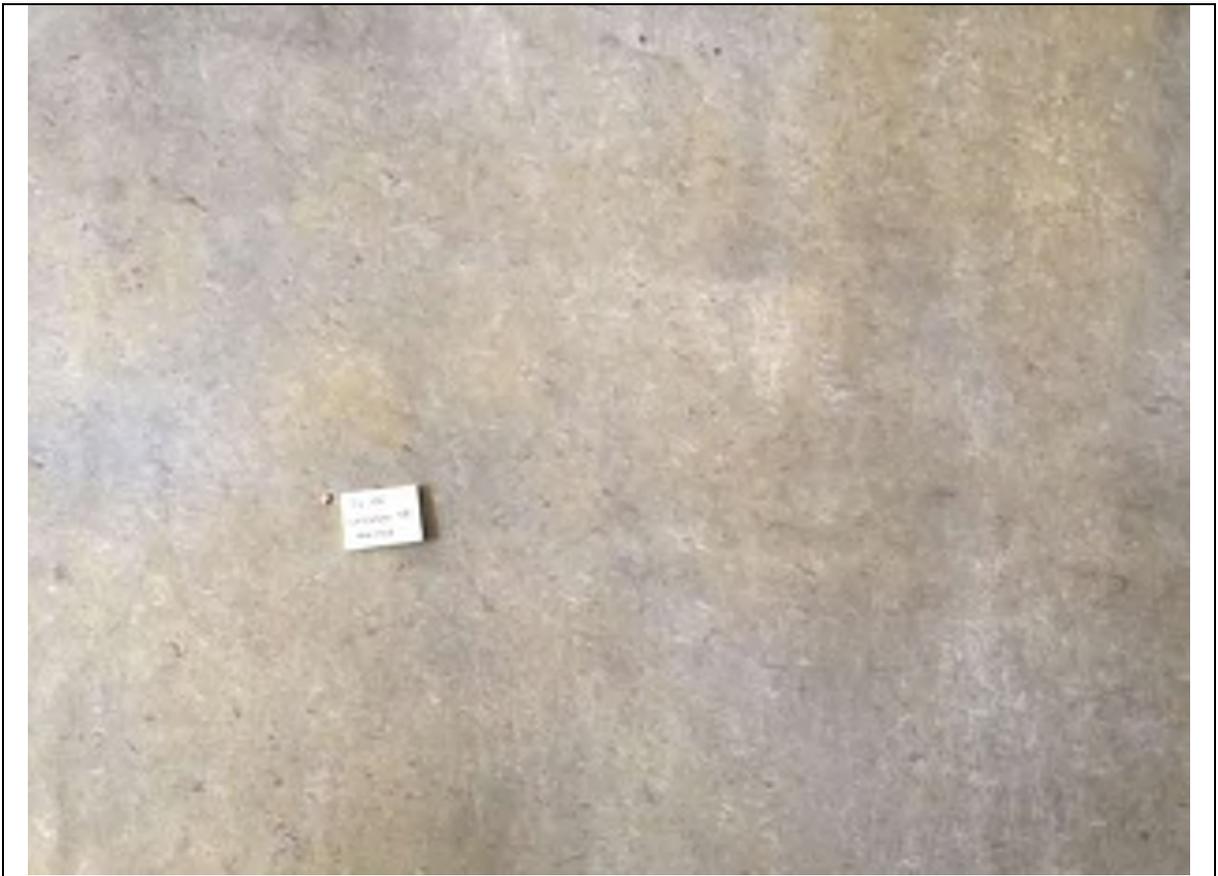
Picture No. 23: Non asbestos vinyl floor sheeting (I5)

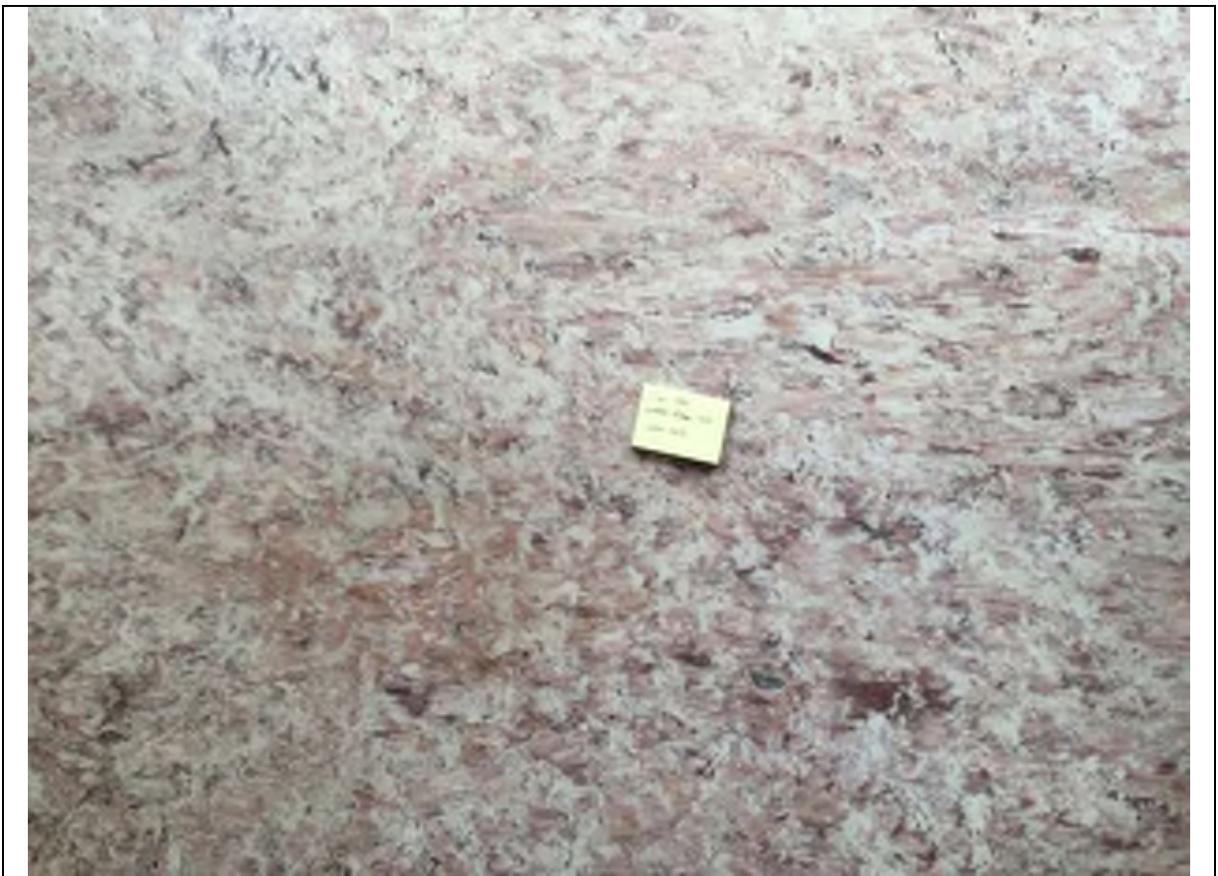
Picture No. 24: Non asbestos vinyl floor sheeting (I6)

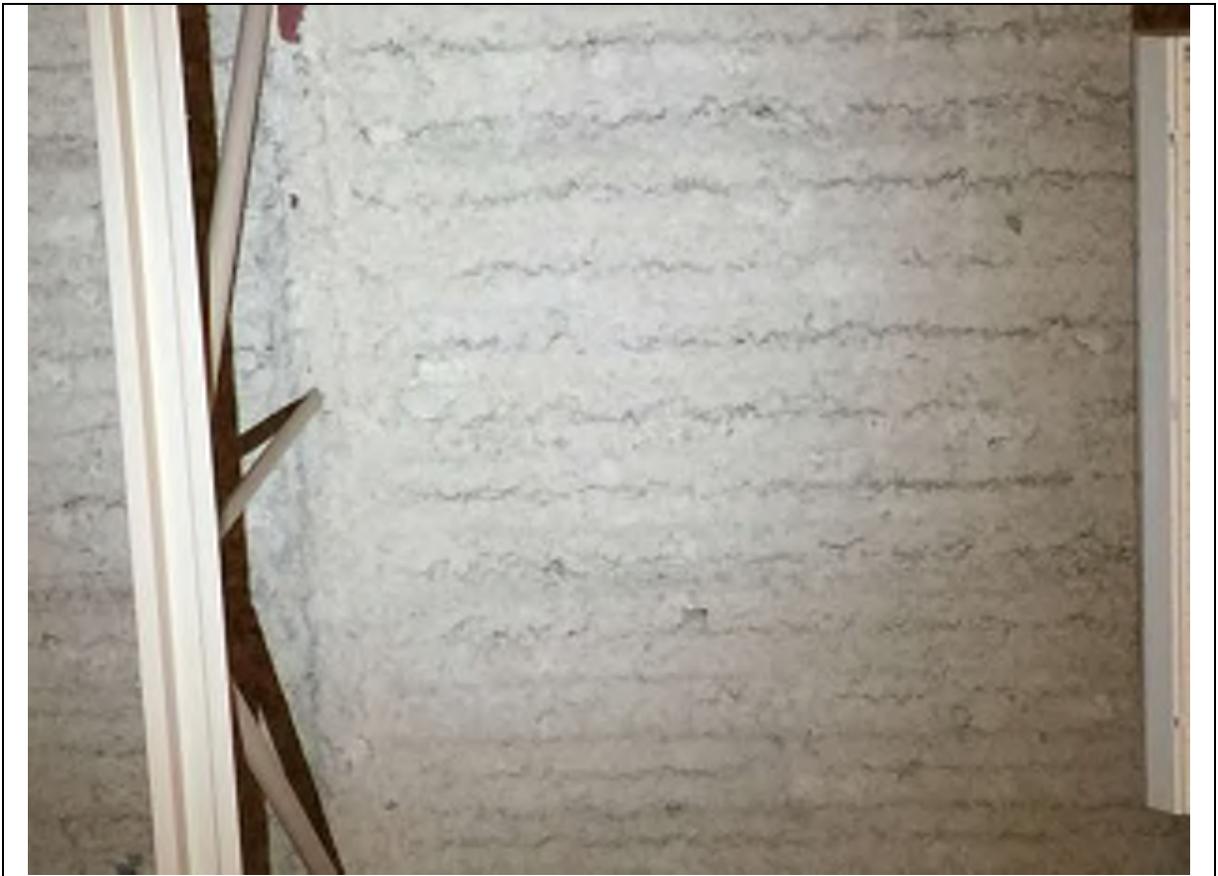
Picture No. 30: Suspect asbestos mastic on acoustic insulation (M5)

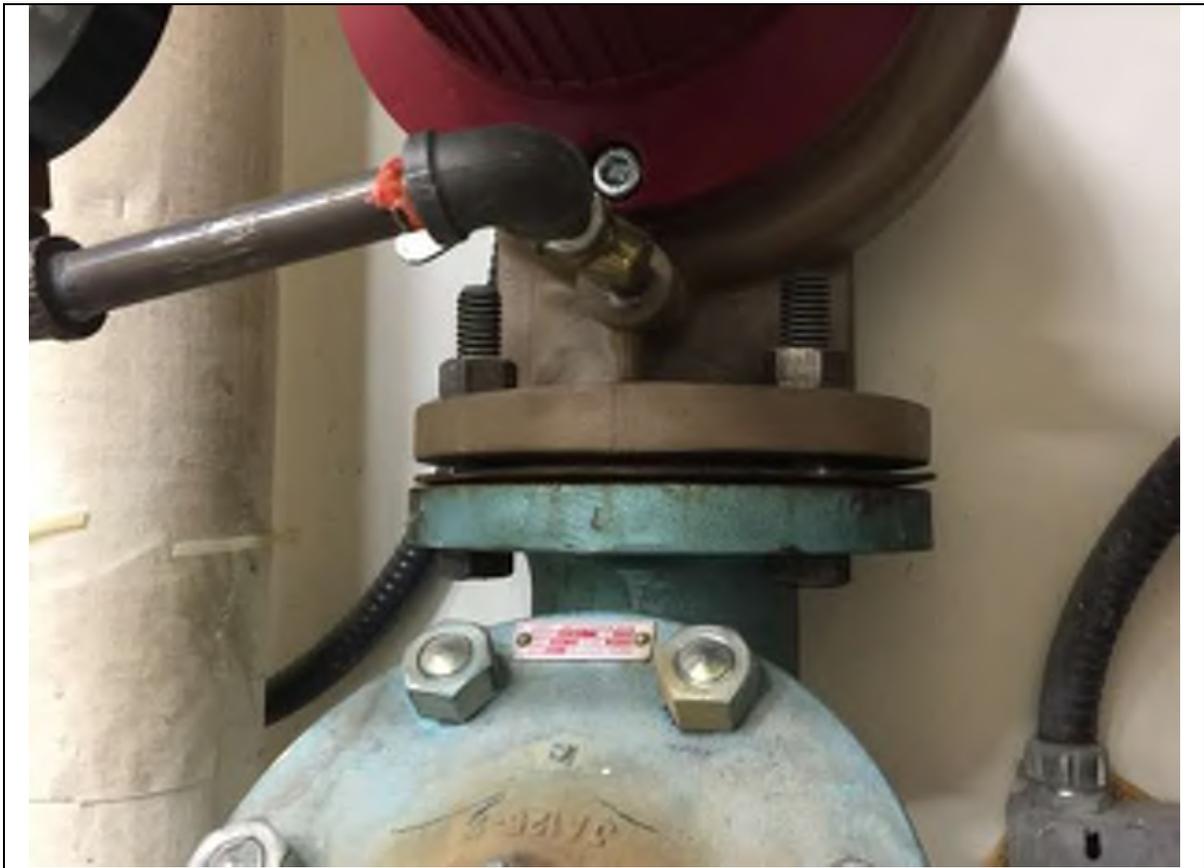
Picture No. 31: *Potential for asbestos pipe flange gaskets*
